Subject: Exchange of elevator hinge bolts

Effectivity: Glider ASTIR CS
all serial-no. 1001 to 1536

Technical information

TM 306-17

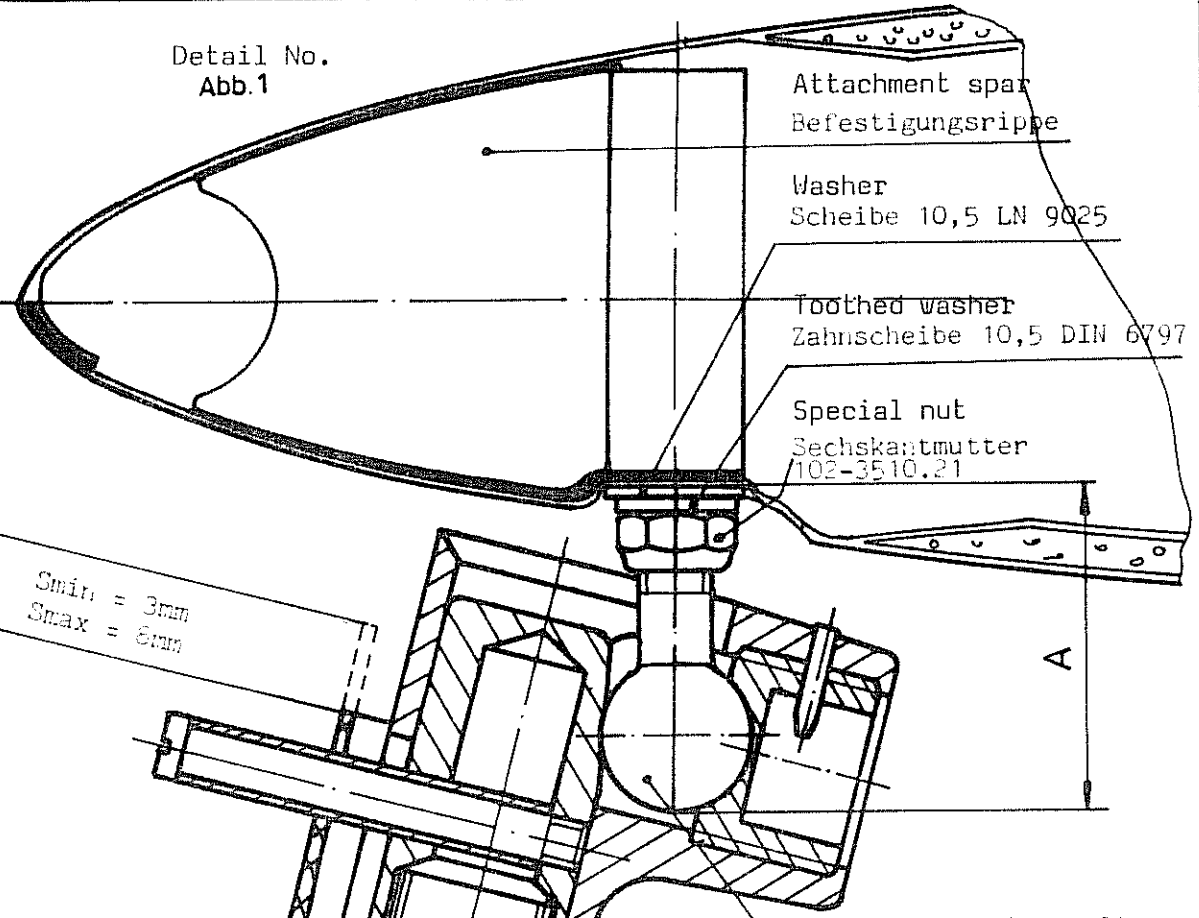
Detail No.
 Abb.1

Reason: At the above mentioned aircraft cracks have been found at the locking bolt in the area of the cutted thread and at the retaining pins in the hardened surface. Only a small number of ASTIR CS are affected which serial numbers cannot be definitely determined. During longer operation of the aircraft those cracks may aggravate and we advise to replace all elevator hinge bolts. The new bolts are inspected in a special crack test.

- Mount the tail unit properly and couple the control-rods. Check for safe installation. If the lockingplate in front of the fin moves less than 3 mm (0.12 in.) from the "unlock" to the "locked" position the diameter of the ball is too small and not allowable play can be expected (see detail no. 2). A larger locking bolt must be installed.

Instructions: 1. Replacement of the spheric locking bolt at the elevator leading edge (see detail 1 and 2)

- Mount the modified locking bolt (102-3500.21) with a toothed washer 10,5 (DIN 6797 phr) and the nut (102-3510.21) according to detail no. 1. Adjust the bolt to the correct installation depth (A) and lock it by holding the ball with the screwdriver and tightening the nut with the wrench. Afterwards apply a small line of red color from the shaft of the bolt across the nut to the elevator surface to indicate unintentional rotation.
