Subject: Inspection and replacement of spar spigot assemblies

Concerning: Model: ASTIR CS TCDS No.: 306
- Series: - S/N:
ASTIR CS 1001-1536
ASTIR CS 77 1601-1844
ASTIR CS Jeans 2001-2248
CLUB ASTIR II 5001-5061 (Suffix "C")
STANDARD ASTIR II 5001-5061 (Suffix "S")
G 102 CLUB ASTIR III 5501 & up (Suffix "C")
G 102 CLUB ASTIR IIIb 5501 & up (Suffix "Cb")
G 102 STANDARD ASTIR III 5502 & up (Suffix "S")

Model: SPEED ASTIR II TCDS No.: 320
- Series: - S/N:
SPEED ASTIR II 4001-4027
SPEED ASTIR IIB 4028-4107

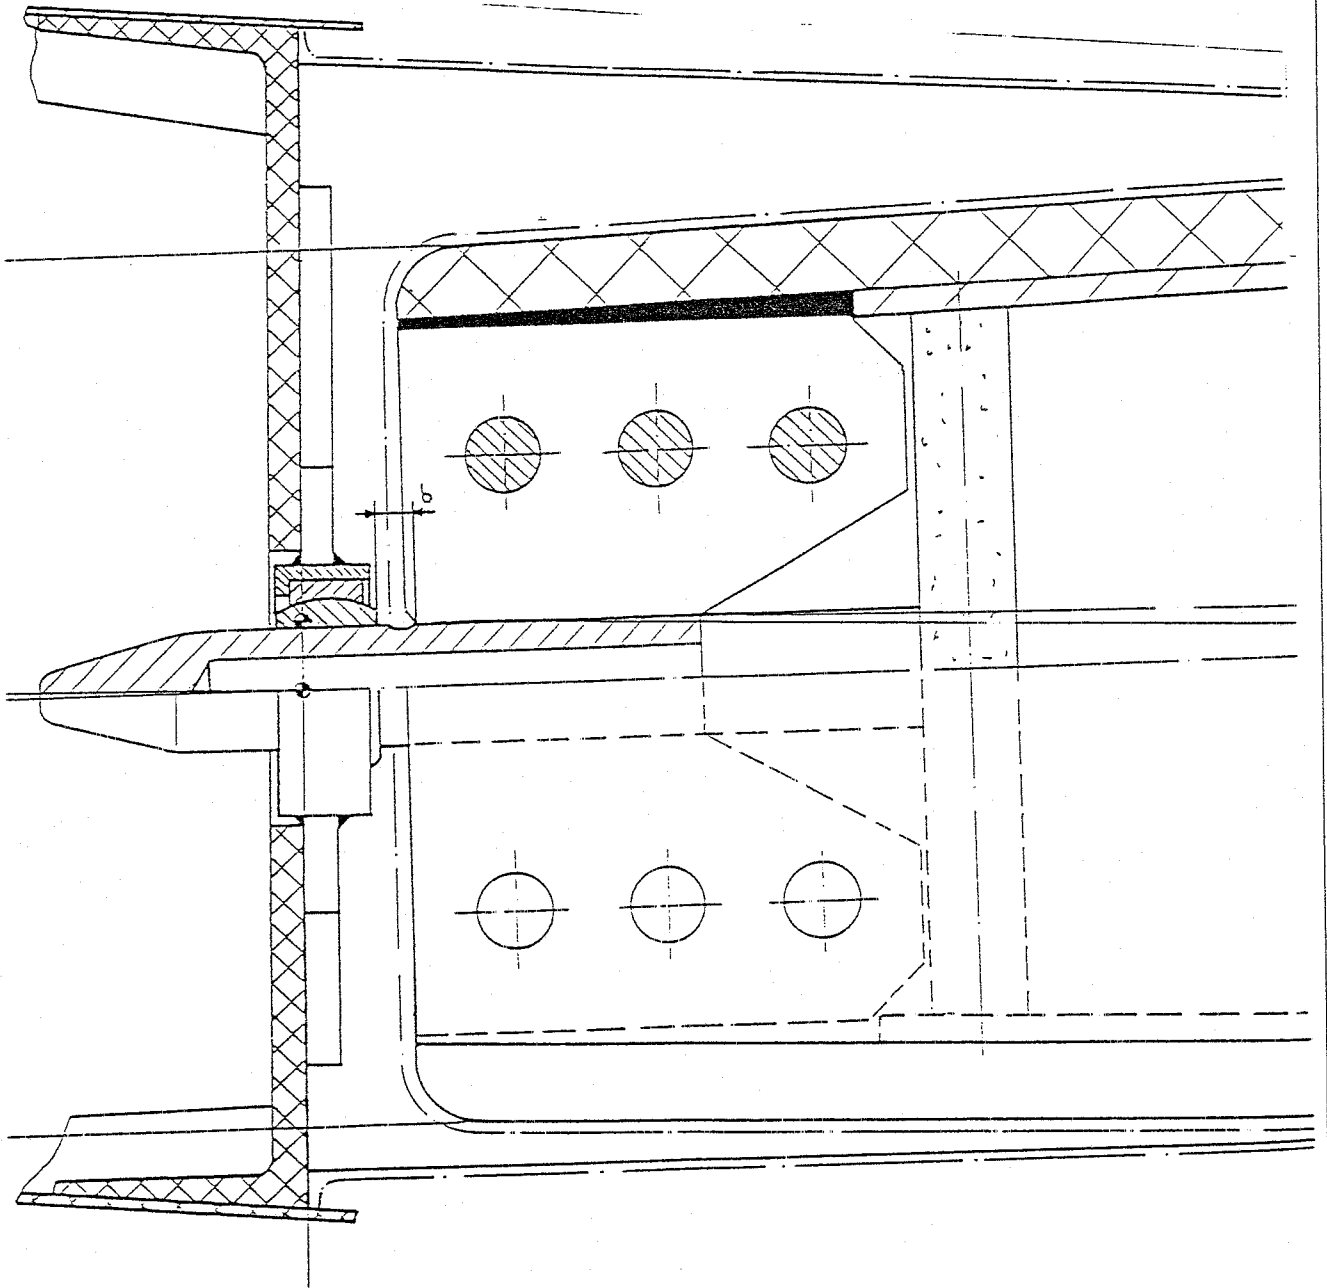
Definition of the distance b

If no crack is discovered and if the distance between spigot plates and swivel bearing is (refer to figure on page 3):

- $b \leq 10$ mm: Carry out Action 2 not later than 31 December 1992
- $b > 10$ mm: Carry out Action 2 not later than 30 June 1991

If a crack is discovered and if the distance between spigot plates and swivel bearing is $b \leq 10$ mm, the crack may initially be blended out (refer to page 4 for procedure):

If a crack is discovered and if the distance between spigot plates and swivel bearing is $b > 10$ mm, Action 2 must be carried out immediately.

2. Replacement of the spar spigot assembly
Replace the spar spigot assembly in accordance with Installation Instruction No. 306-29/320-5.

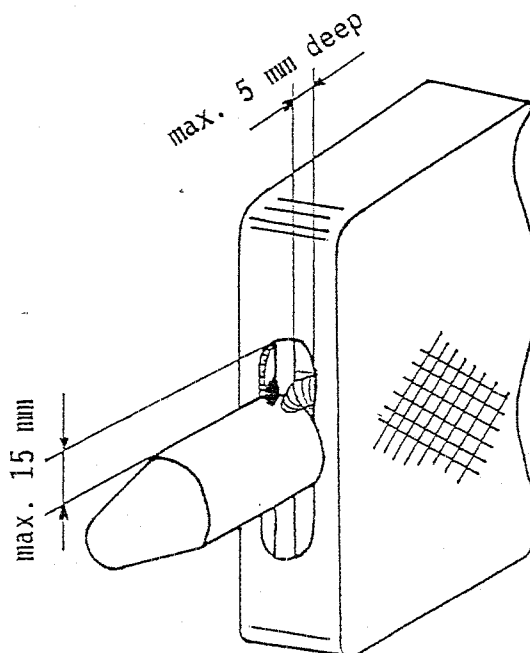
Comments to crack inspection

To perform the crack inspection the section of the wrapping around the main spigot has to be removed (max. 15 mm) and the adhesive material removed to expose the welding seam (max. 5 mm deep, see figure). Be very careful not to scratch or otherwise damage the spigot or plate.

If the weld seam is continuous around the plate, the complete toe of the welding seam has to be inspected. Grooves or nicks in the surface of the welding seam which are not part of a crack must be polished out and the crack inspection performed again.

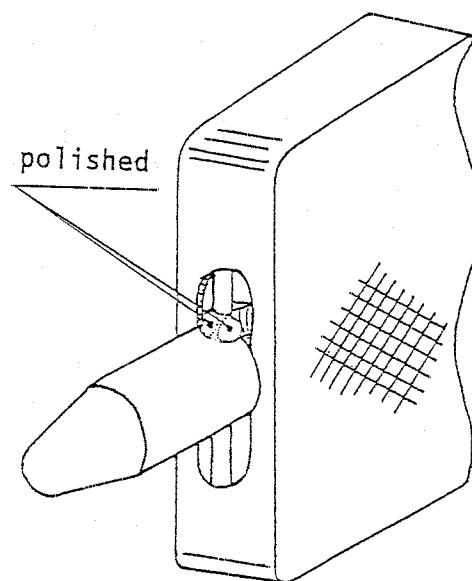
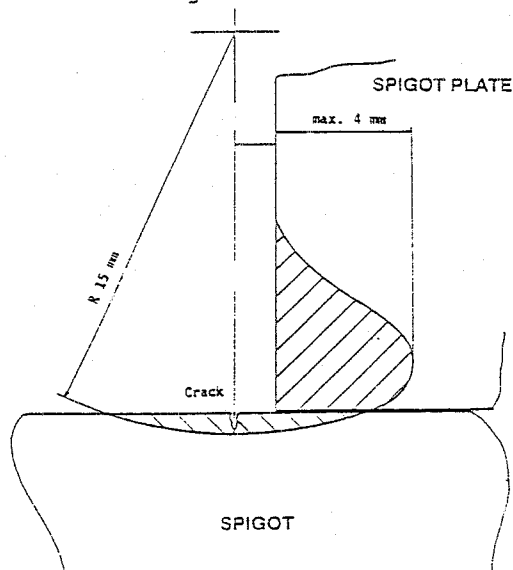
A crack may be blended out if the following conditions are fulfilled:

- * crack on one side not deeper than 0.75 mm
- * cracks on both sides not deeper than 0.5 mm each

Blending out should be done with grinding caps or equivalent. The grinded surface has to be polished.

Sketch mentioned below shows a cross section of blending out a crack.

Finally apply a coating of resin to the exposed area (wood and metal).
