## SERVICE BULLETIN MSB 315-72 SERVICE BULLETIN MSB 869-23

#### 1.4 Subject:

ATA-Code:	55-00	Stabilizer
	55-40	Rudder

TWIN II; TWIN II ACRO; TWIN III; TWIN III ACRO; TWIN III SL

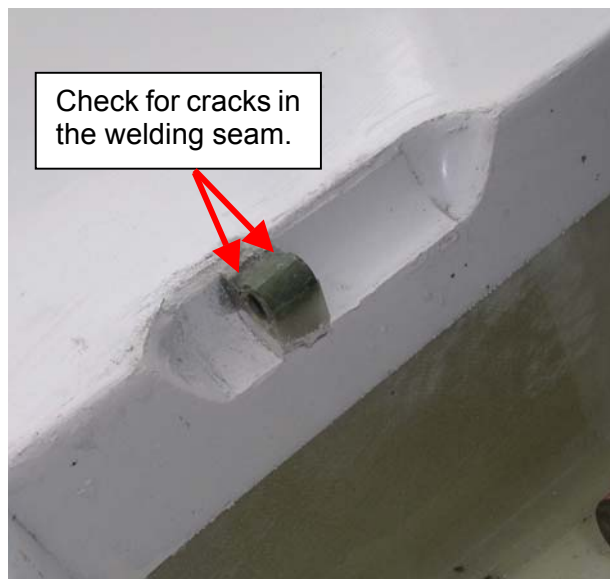
**Abb. 1**

A broken upper rudder hinge on a TWIN III ACRO, detected during pre-flight inspection – was reported to GROB. The metallurgical investigation of the hinge indicated the typical crack pattern of a bending fracture. The crack pattern also suggests earlier damage, possibly caused by bending and forced bending back. As a cautionary measure to preclude any risk, a visual inspection of the upper rudder hinge is mandated. Any findings shall be reported to GROB, so that additional action may be taken as required.

- 1.8.1. Check rudder for excessive play in the upper rudder hinge before removal. Permissible radial play: Minimum 0.01mm, Maximum 0,08mm.
- 1.8.2. Remove rudder, store rudder on suitable support.
- 1.8.3. Visually inspect (magnifying glass 1:10) upper rudder hinge, in particular area marked in fig. 1. Check for cracks in the welding seam.

- 1.8.4. Damaged or bent rudder hinges shall be exchanged in accordance with Repair Instruction RI 315-72. Bending back of hinges is not approved.
- 1.8.5. Install rudder after repair, or in case no damage was observed. If excessive play was noted in 1.8.1., install rudder with new DU-bushings.
- 1.8.6. Check rudder full and unrestricted range of movement.
- 1.8.7. Manually amend Maintenance Manual, section "Periodic Inspection": Comply with SB 315-72, steps 1.8.1 through 1.8.6.
- 1.8.8. Any hinge found damaged, return to GROB, advise aircraft serial-number.

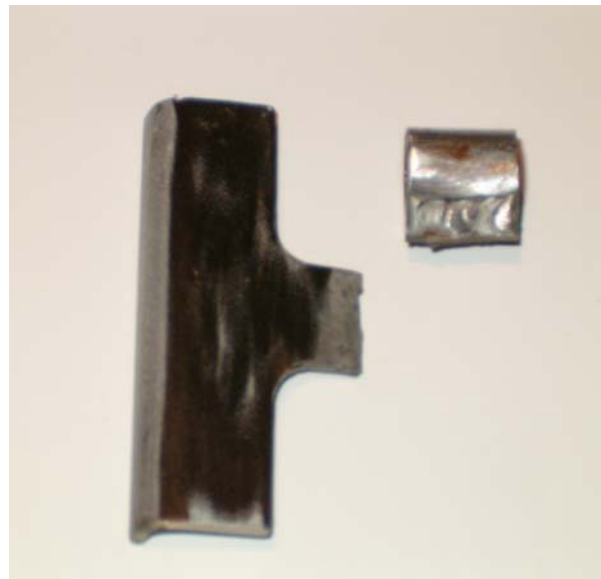
**Abb. 2**

**Note:** Capillary fissures may be observed between rudder hinge and surrounding GRP, this is entirely normal, since metal and GRP do not form a homogeneous structure.
