Subject: Mounting of cable pulley in case of cable release.

Effectivity: Sail plane ASTIR CS, work no. 1070 - 1199 and work no. 1300 - 1315.

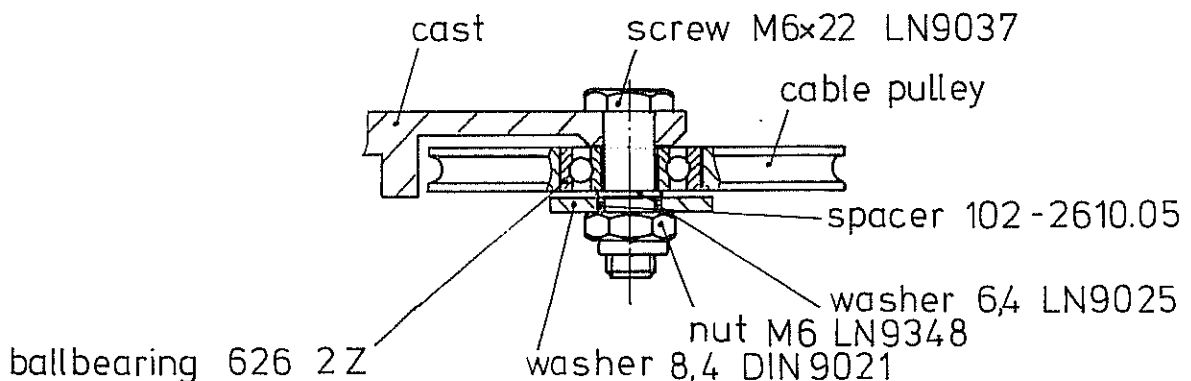
Reason: We have observed that in case of overstressing (we have learned from a damaged aircraft) the cable pulley shifts its position from the ball-bearing with slight lateral movement. By adding a large disc this problem can be eliminated.

Instructions: See sketch.

1. Examine carefully whether washer 8,4 DIN 9021 and spacer 102-2610.05 are placed correctly according to sketch. The cable pulleys are located on the left side of the undercarriage box and under the instrument panel.
2. If the washer 8,4 DIN 9021 and spacer 102-2610.05 is missing, fix the two included samples additional to the washer 6,4 LN 9025 with new hexagonal nut M 6 / LN 9348, according to the sketch.

Material: In the post supply will be delivered 2 washers 8,4 DIN 9021, 2 spacers 102-2610.05 also 2 hexagonal nuts M 6 LN 9348.
