Subject: Replacement of Hotellier-Quicklinks of the elevator system

Effectivity: Sailplane ASTIR CS:
all Serial-N^o. from 1001.
Sailplane ASTIR CS 77:
all Serial-N^o. from 1601.
Sailplane ASTIR CS JEANS:
all Serial-N^o. from 2001.

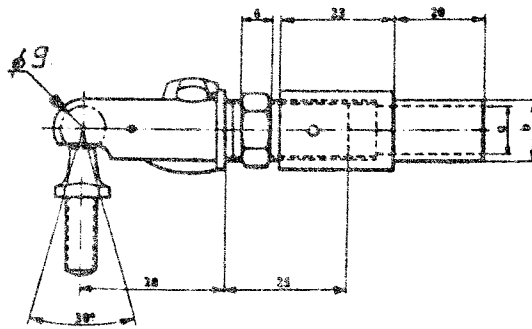
Detail N^o. 1

Correct joint with normal swivel-housing and wedge-type slide R 9.41.

Step 2. If not yet installed, cam-type links R9.45. (detail N^o. 2) or Z-housing links (open housing) RZ 9.41. (detail N^o. 3) must be replaced by links R9.41. (detail N^o. 1) with closed housing and wedge-type slide. Swivel N^o. 961 M has to be also replaced by a new one.

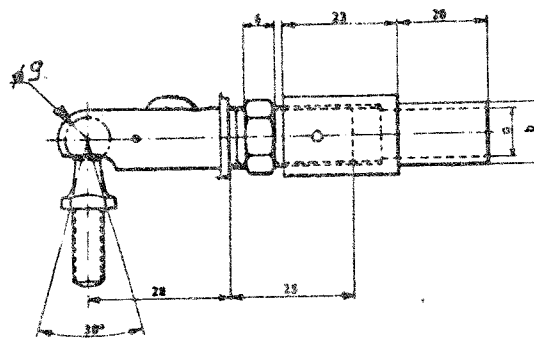
Detail N^o. 2

Cam-type links have to be rejected and replaced.

not permitted joint with cam-type lock R 9.45.

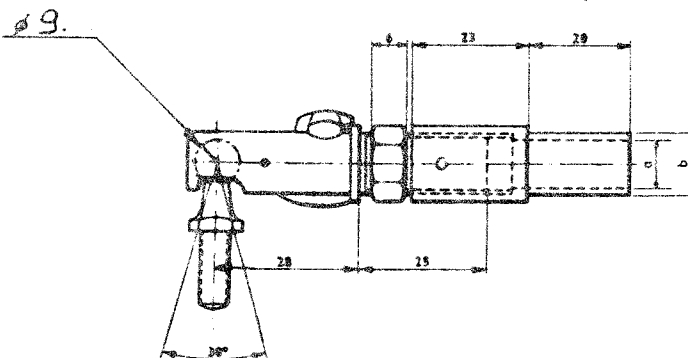
Detail N^o. 3

Reason: At other types of aircraft several fractures of the 90^o-quick-connections with open housing due to strong wear and tear after a high total aircraft-time were observed at the swivels of the aileron links which requires the exchange of the above mentioned joints against those with closed housing and new swivels.

not permitted joint with open swivel-housing (Z-housing) RZ 9.41.
