Technical Information
TM 306-22

GROB G 102
CLUB ASTIR III and IIIb
STANDARD ASTIR III

Subject: Inspection and exchange of the slide at the pedal unit.

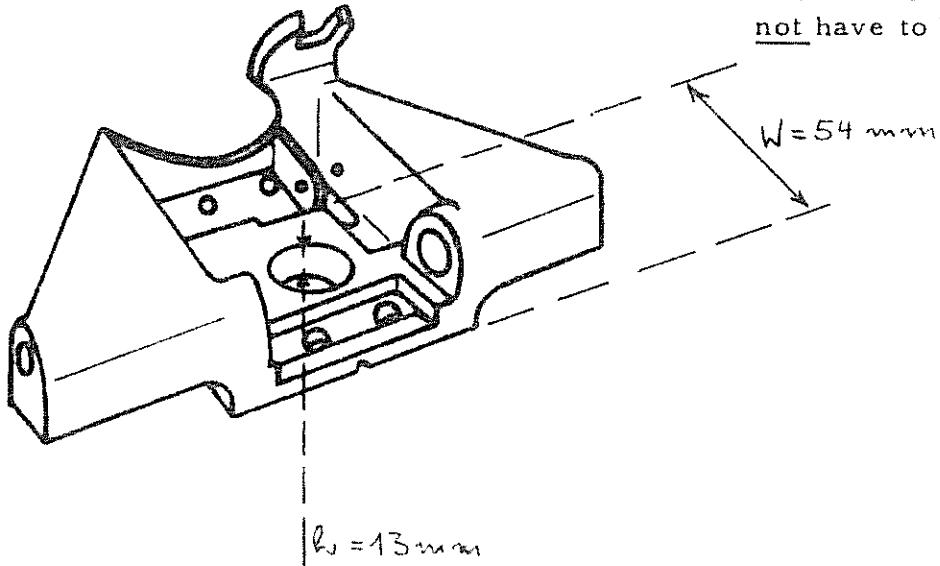
Picture 1 :

Slide no. 103B - 4208.10

This slide with wide, high cross-web is safe and does not have to be exchanged.

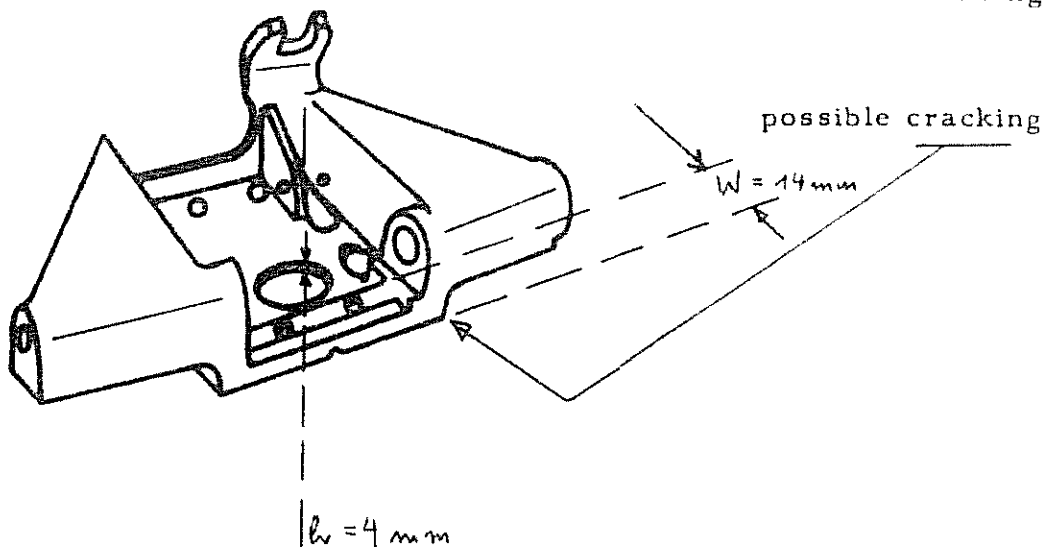
Picture 2 :

Reason: At the pedal unit of the mentioned serial numbers, slides were partially mounted which might break when overloaded.

Slide no. 103 - 4208.10

This slide with small, low cross-web is rejected and has to be exchanged.

Instructions: Instruction 1:
Inspection of the slide at the pedal unit before next start. If the slide no. 103B-4208.10 (picture 1) with the wide, high cross-web is installed, there is no reason for reclamation. Instructions 1 and 2 are not applicable.
If the slide no. 103-4208.10 (picture 2) with the small low cross-web is installed, instructions 2 and 3 have to be carried out.
Instruction 2:
Until realization of instruction 3, the slide at the pedal suspensions has to be inspected for cracks and deformations before each flight and the function of the pedal adjustment and the rudder control has to be checked. If there is any damage, instruction 3 has to be carried out before the next start. Until exchanged, when adjusting the pedals, the locking bar has to be relieved with the least possible power of the heel to the lower tube of the pedals.
Instruction 3:
The slide no. 103-4208.10 (picture 2) has to be exchanged against slide no. 103B-4208.10 (picture 1) not later than June 15, 1983. The necessary material for this purpose (see below) has to be ordered from the manufacturer with the attached order form and it has to be proceeded according to repair instructions no. 306-22.
