Technical Information
TM 306-26

ASTIR CS
ASTIR CS 77
ASTIR CS Jeans
CLUB ASTIR II
STANDARD ASTIR II

Subject: Inspection and exchange of the airbrake locking levers in the wing.

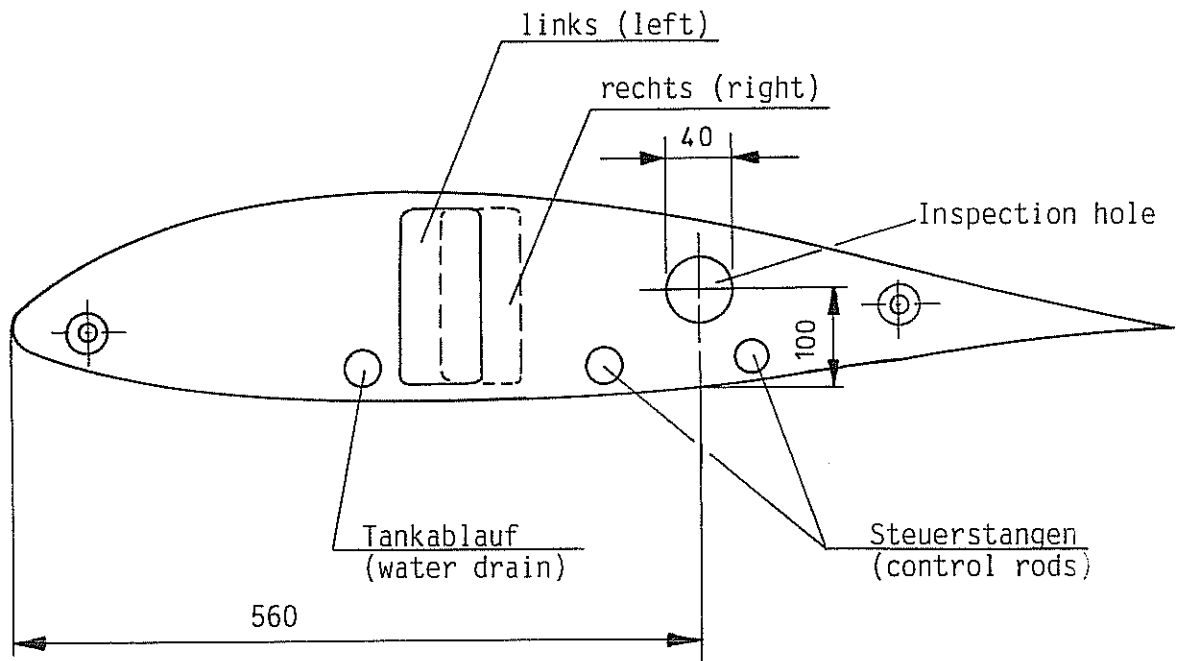
Instructions: 1. Instruction: Installation of an inspection hole in the root rib before the next start.
1.1. At the ASTIR CS, CS 77 and CS Jeans an inspection hole has to be installed in the rear part of the right and the left root rib according to the below shown sketch.

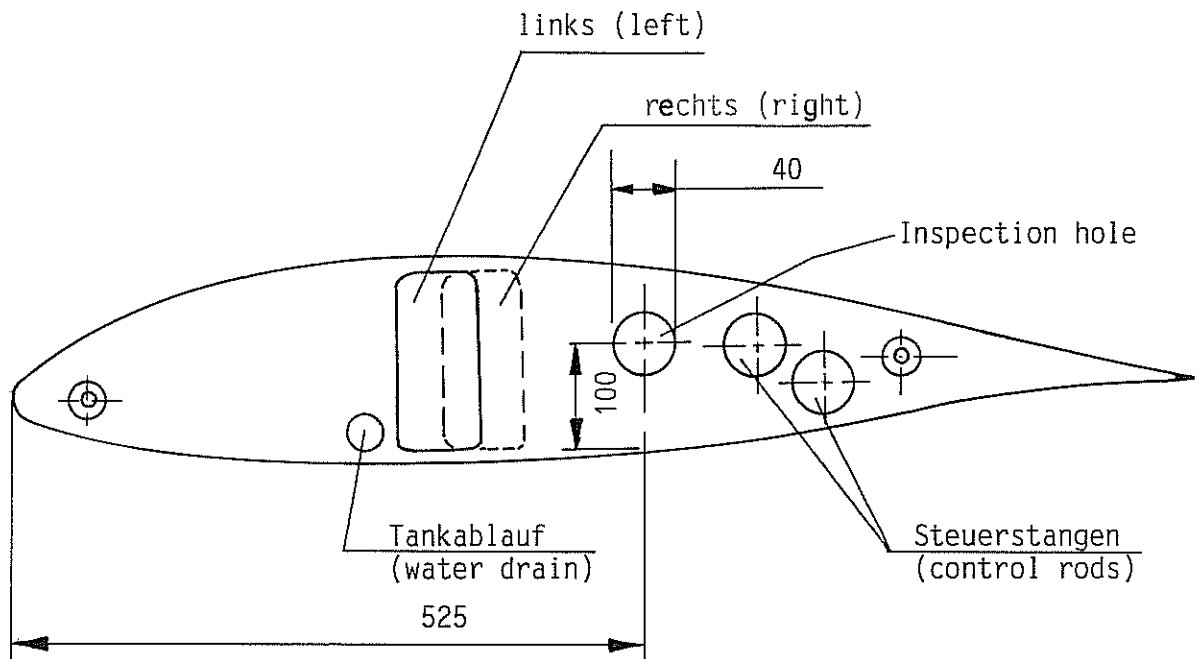
- 1.2. At the CLUB and STANDARD ASTIR II an inspection hole has to be installed in the rear part of the right and the left root rib according to the below shown sketch.

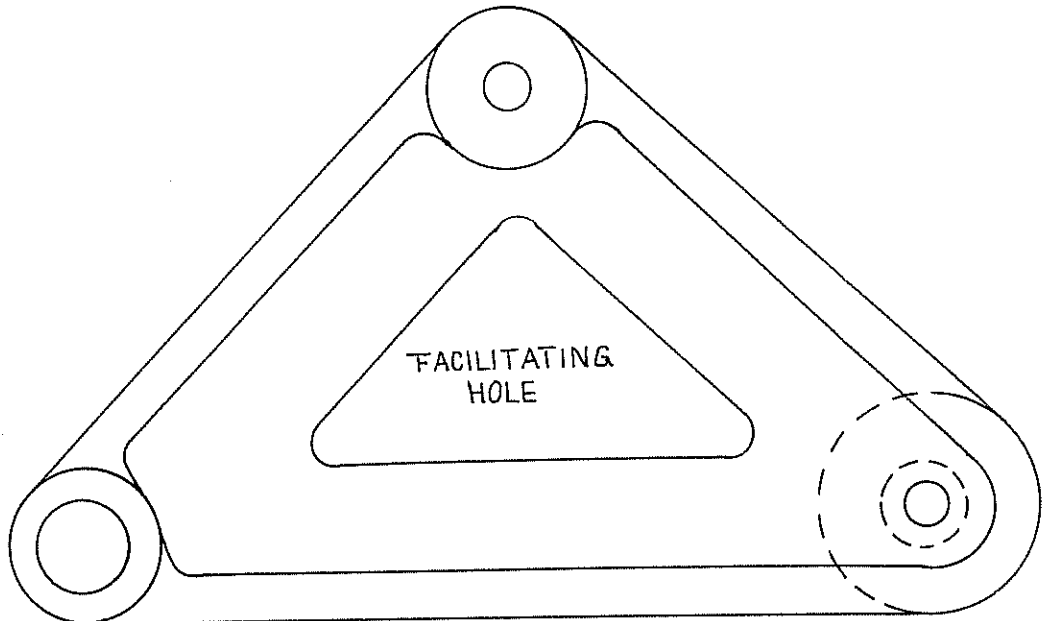
Reason: This Technical Information is caused by sporadic damages of the aluminium casting airbrake levers with facilitating hole which are installed in the wings of the above mentioned ASTIR-glidern. First, cracks occur in one leg of the levers, which, in an advanced phase, can result in a fracture which means a one-sided failure of the airbrake.
As a precaution, inspection holes must be installed in the region of the airbrake locking levers. In case of damage the levers must be exchanged.

- 1.3. Through the inspection hole the airbrake locking lever has to be controlled at the rear of the spar which is mounted app. 1,25 m away from the root rib.

- 1.4. If a solid constructed lever of aluminium casting without hole is found, further actions are not applicable until the 3000-hours-check (see instruction 4.4.)

- 1.5. If a lever of aluminium casting with facilitating hole is found, the following instructions have to be carried out.
2. Instruction: Installation of an inspection hole with sight-window into the wing underside in the region of the airbrake locking levers. (See repair instruction 306-26/1).
