Subject: Exchange of the elevator lever

Concerned: ASTIR CS S/N 1001 - 1536
ASTIR CS 77 S/N 1601 - 1844
ASTIR CS Jeans S/N 2001 - 2248

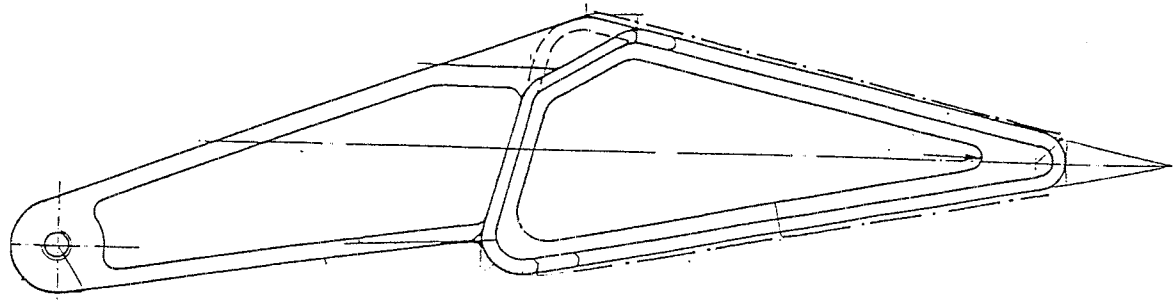
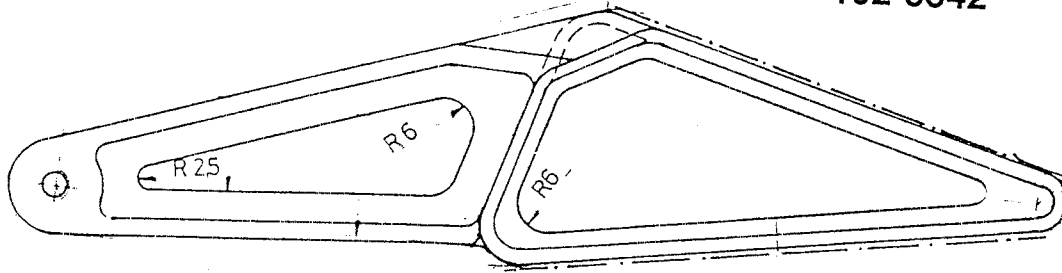
Fig. 1

Procedure: The exchange of the elevator lever P/N 102-3542, made from aluminum castings (refer to Fig. 1, page 2) or made from aluminum sheet with openings/ lightening holes P/N 102-3541 (refer to Fig. 2, page 2), is already anticipated within the course of extension of the service life before reaching 3000 flight hours (refer to Service Bulletin TM 306-30). Now an inspection and an advanced exchange of the elevator lever by the elevator lever P/N 102-3543, made from aluminum sheet (refer to Fig. 3, page 3), is mandatory as a precautionary measure.

The elevator lever P/N 102-3542 (aluminum castings, Fig. 1) has to be checked for cracks using a proper test procedure (i.e. magnifying glass). If cracks are found, the elevator lever has to be exchanged according to the Installation Instructions No. 306-30/1, before the next flight.

If no cracks have been found during the inspection according to Action 1, the castings elevator lever and all other lever models have to be exchanged by the elevator lever P/N 102-3543, made from aluminum sheet (refer to Fig. 3, page 3) according to the Installation Instructions No. 306-30/1 not later than 31.12.1994.
