# SERVICE BULLETIN NO. MSB306-37/2 MSB320-08/2

CLUB ASTIR II

SPEED ASTIR II

#### **Modification of the Canopy Jettison System**

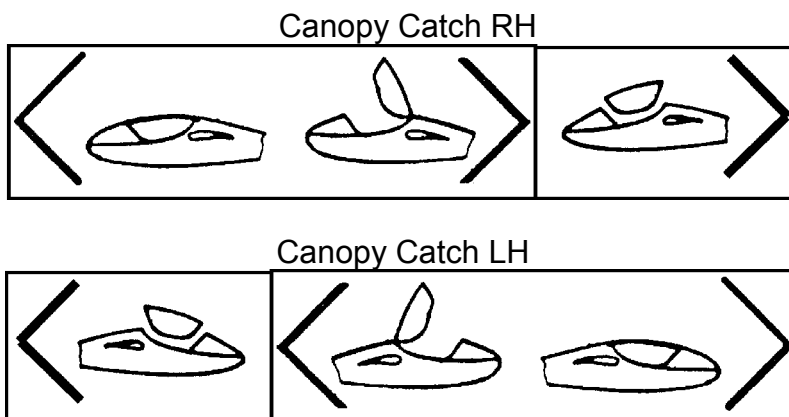
**B.** At the LH and RH canopy both placards “Canopy Catch” must be replaced by the new placards (“Canopy Catch + Emergency Jettison”):

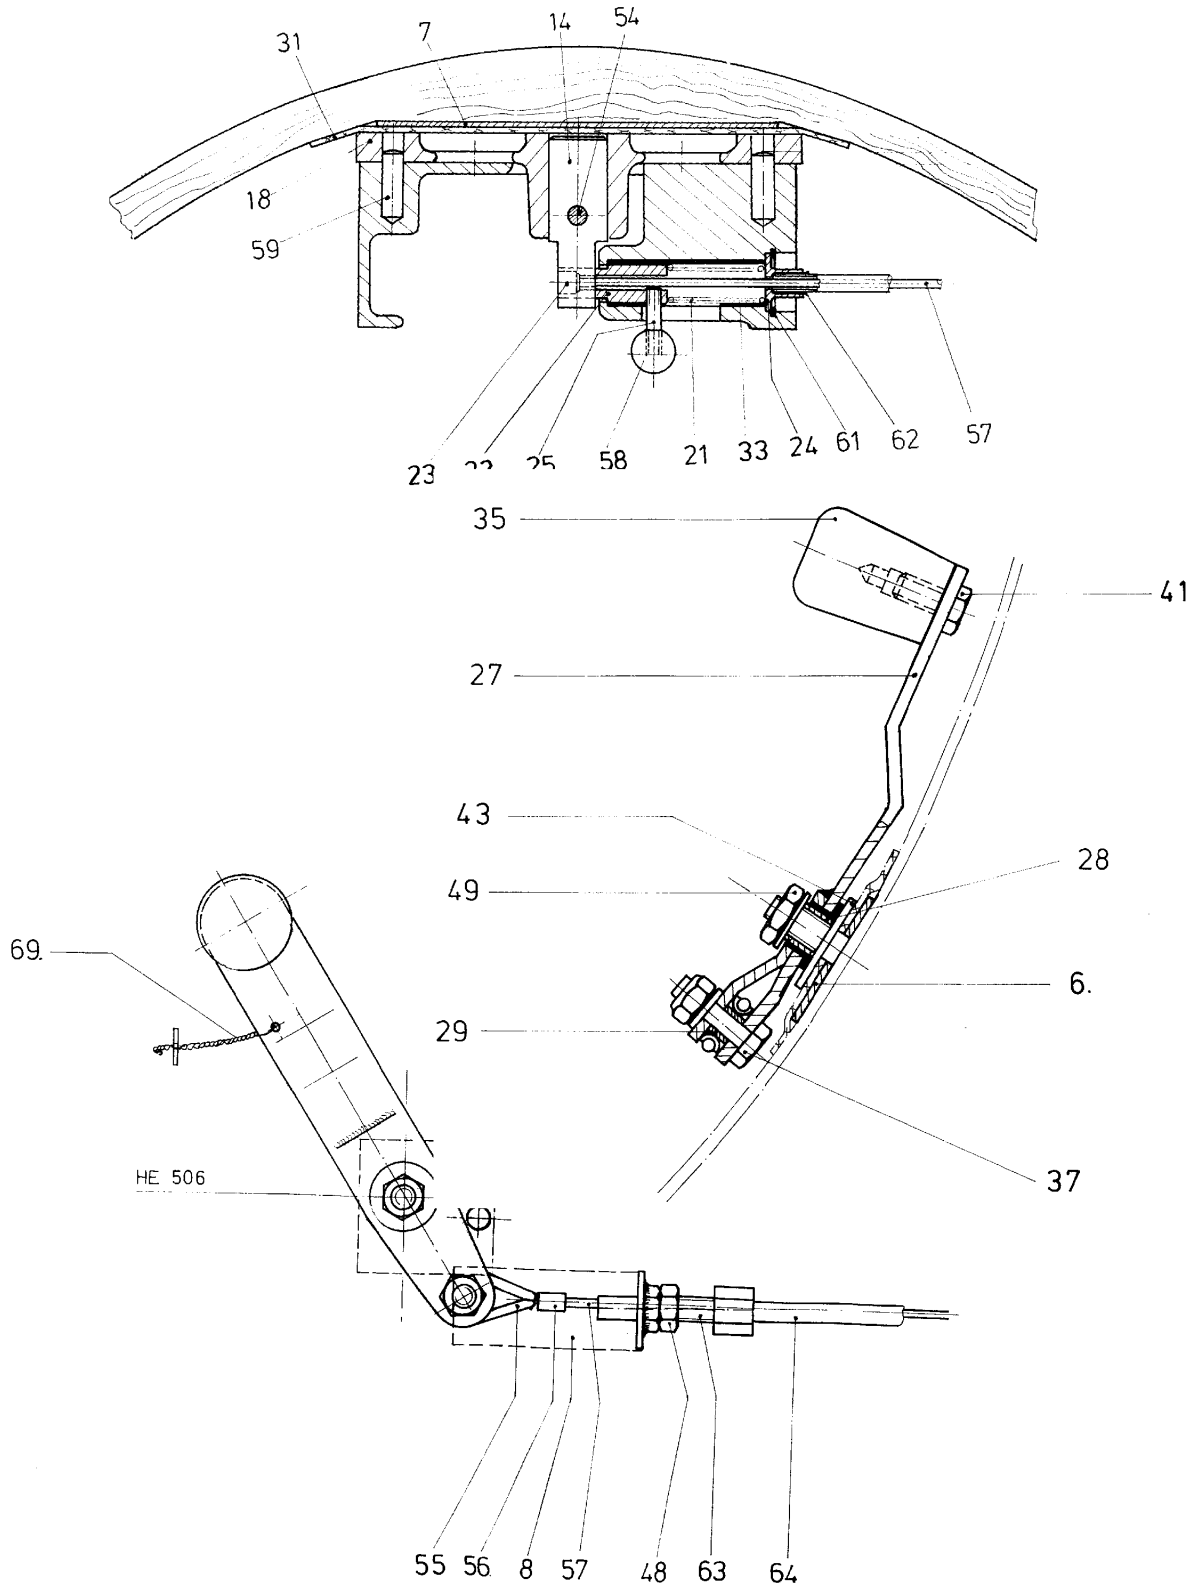
1.8.2 The canopy jettison operating lever including operating cable must be removed as follows (refer to illustration on page 4):

- remove the RH cockpit covering
- remove bolt (37)
- cut-off cable (57) and remove adjusting screw (48) and remove completely operating cable (64)
- remove safety wire (69)
- remove nut (49) and operating lever (27)
- cut-off cable (57) from canopy joint
- remove cable rest with socket (62) and nipple (23)
- install RH cockpit covering
- remove placard "Canopy Jettison" from canopy jettison operating lever

NOTE: The canopy can be removed for maintenance purposes by operating the red ball knob (58)
