Technical Information TM 315-20

GROB G 103 "TWIN II"

GROB G 103 A "TWIN II ACRO"

Subject : Inspection and exchange of the slide at the front pedal unit.

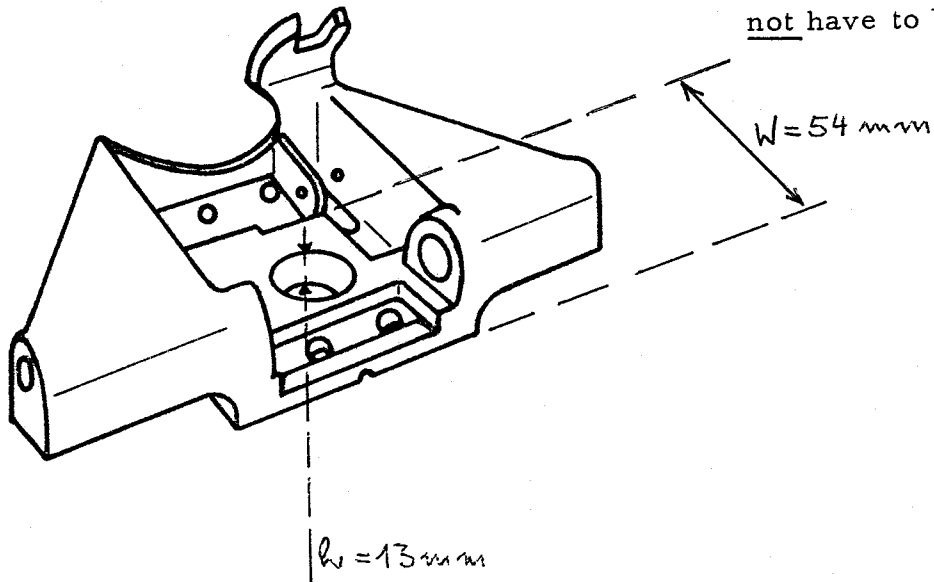
Picture 1 :

Instructions : Instruction 1 :  
Inspection of the slide at the front pedal unit before next start. If the slide no. 103B-4208.10 (picture 1) with the wide, high cross-web is installed, there is no reason for reclamation. Instructions 1 and 2 are not applicable.

Slide no. 103B - 4208.10

This slide with wide, high cross-web is safe and does not have to be exchanged.

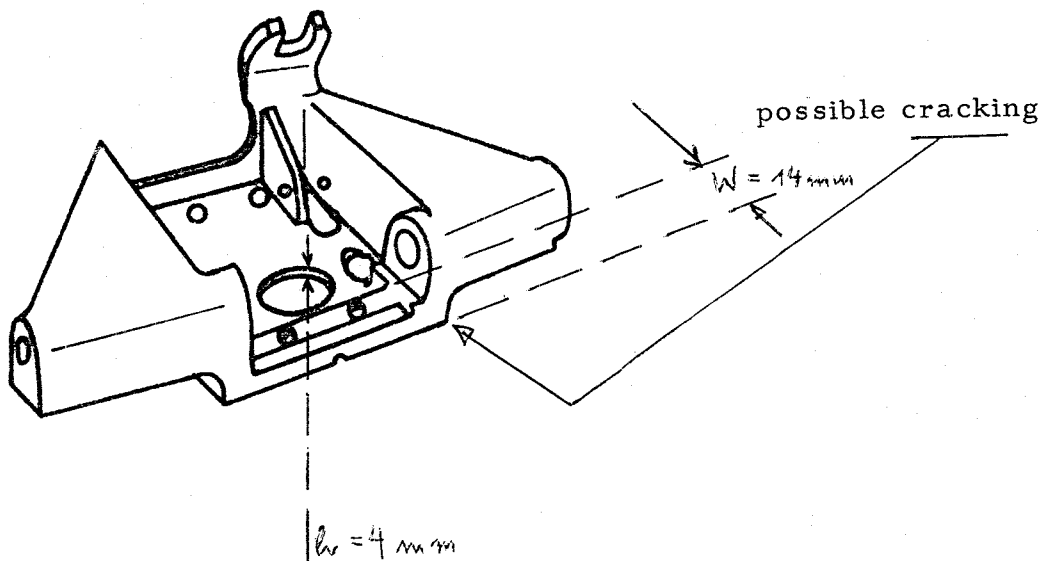
Picture 2 :

Reason : At the front pedal units of the mentioned serial numbers, slides were partially mounted which might break when overloaded.

If the slide no. 103-4208.10 (picture 2) with the small low cross-web is installed, instructions 2 and 3 have to be carried out.

Slide no. 103 - 4208.10

This slide with small, low cross-web is rejected and has to be exchanged.

Instruction 2 :  
Until realization of instruction 3, the slide at the right pedal suspension has to be inspected for cracks and deformations before each flight and the function of the pedal adjustment and the rudder control has to be checked. If there is any damage, instruction 3 has to be carried out before the next start. Until exchanged, when adjusting the pedals, the locking bar has to be relieved with the least possible power of the heel to the lower tube of the pedals.

Instruction 3 :  
The slide no. 103-4208.10 (picture 2) has to be exchanged against slide no. 103B-4208.10 (picture 1) not later than October 31, 1982. The necessary material for this purpose (see below) has to be ordered from the manufacturer with the attached order form and it has to be proceeded according
