Subject: Extension of operational limitations

Concerned: G 103C TWIN III, S/N's 36001 - 36014

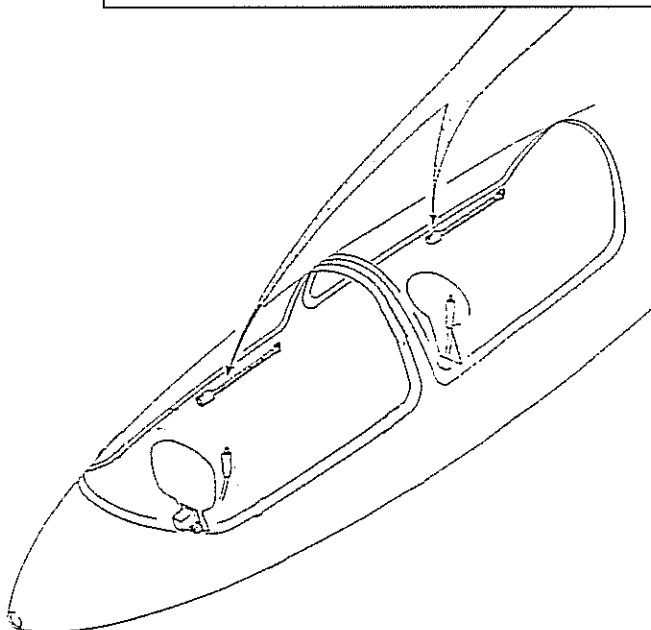
600 kg (1323 lbs)		
Maximum flying weight		km/h	kts	mph
Maximum airspeeds:				
in calm air:	V_{NE}	260	140	162
in rough air:	V_{RA}	194	105	121
Aerotow:	V_T	175	95	109
Winch/ Automobile tow:	V_W	140	76	87
Airbrakes extended:	V_{FE}	260	140	162
Maneuvering speed:	V_A	175	95	109

- Actions:**
1. The following revisions must be entered into the manuals:
 - Flight Manual (German issue) Revision 2 (2/ 18.05.93)
 - Flight Manual (English issue) Revision 2 (2/ 18.05.93)
 - Maintenance Manual (German issue) Revision 3 (3/ 18.05.93)
 - Maintenance Manual (English issue) Revision 3 (3/ 18.05.93)
 2. Installation of new airspeed indicators (new markings) in the front and rear instrument panel.
 3. Airbrake hole blanking (for procedure refer to Service Bulletin TM 315-55).
 4. a. Installation of the following placards to the right side wall of front and rear cockpit (remove old placards!):
