# SERVICE BULLETIN NO. MSB315-62

TWIN ASTIR	S/N	3000 – 3291
TWIN ASTIR TRAINER	S/N	3088 – 3291 (with suffix „T“)
G 103 TWIN II	S/N	3501 – 3729
G 103A TWIN II ACRO	S/N	3544 - 34078 (with suffix „K“)
G 103C TWIN III ACRO	S/N	as of 34101
G 103C TWIN III	S/N	36001 - 36014

**ATA-Code:** N/A  
**C of G release hook**

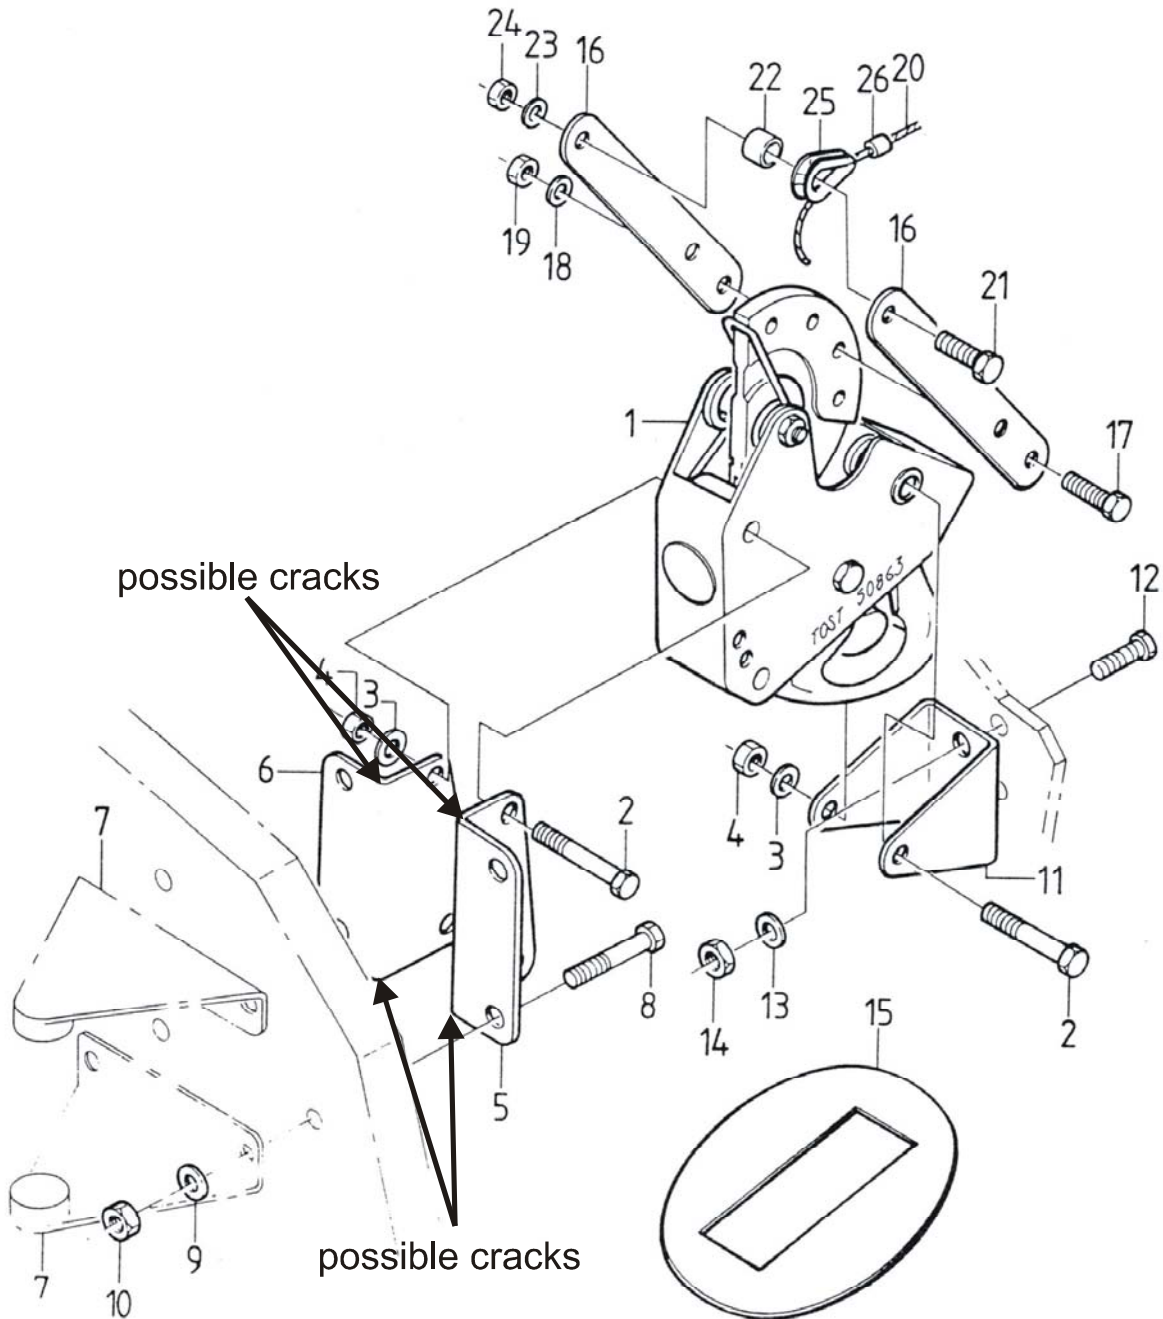
After long time of operation (i.e. towing using the C of G release hook) cracks at the forward C of G release hook attachment brackets might occur.

**Caution:** Illustration below is only for G 103A TWIN II ACRO ! For other models a different arrangement is possible !

**1.8.1** The attachment brackets P/N 103-2235.03 and 103-2235.04 or 103B-2360.01 and 103B-2360.02 must be checked for cracks as follows:

- remove rear seat
- check the brackets for possible cracks, refer to illustration on page 2 (if necessary use mirror and pocket lamp)

**Caution:** If cracks are determined, replace the brackets immediately IAW 1.8.2 !

**1.8.2** Both forward C of G release hook attachment brackets must be replaced as follows:

- remove rear seat
- remove L/H and R/H instrument panel cover
- remove **front** attachment of the C of G hook (item 2, 3, 4), loosen rear attachment (item 12, 13, 14)
- remove attachment brackets (page 2, item 5 and 6)
- install new brackets P/N 103B-2360.01/2 and 103B-2360.02/2

**Caution: On TWIN ASTIR and TWIN ASTIR TRAINER the additional plate P/N 103-2360.02 must be installed below the attachment brackets.**
