SERVICE BULLETIN NO. MSB315-62/2

1.4 Subject:

ATA-Code: N/A C of G release hook

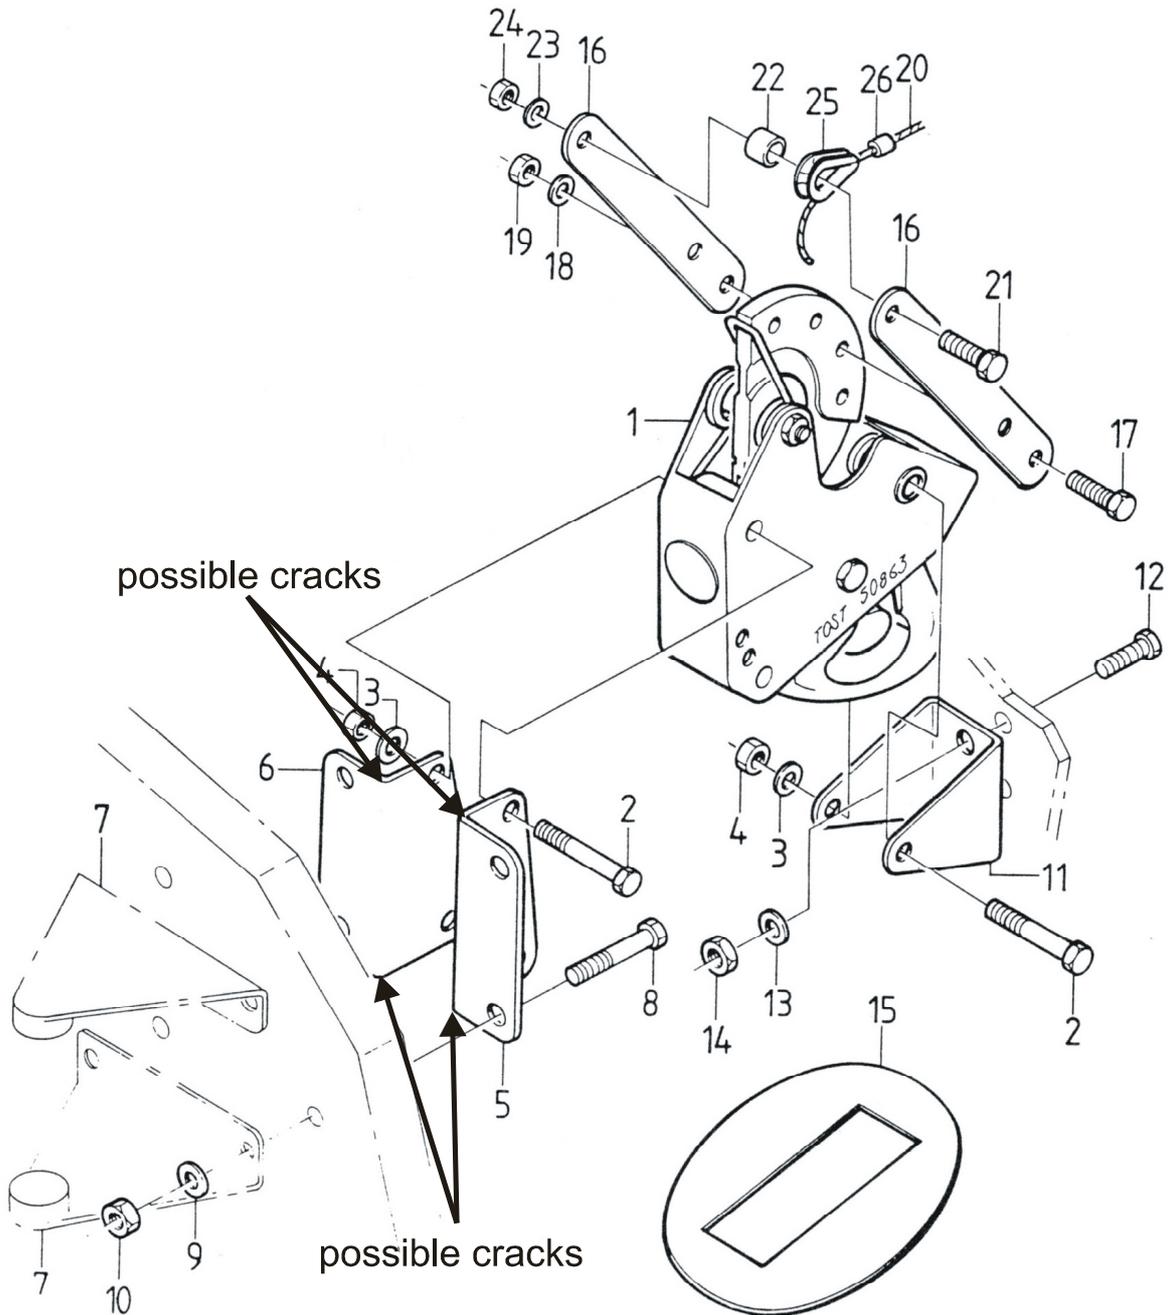
After long time of operation (i.e. towing using the C of G release hook) cracks at the forward C of G release hook attachment brackets might occur.

Caution: Illustration below is only for G 103A TWIN II ACRO! For other models a different arrangement is possible !

1.8.1 The attachment brackets P/N 103-2235.03 and 103-2235.04 or 103B-2360.01 and 103B-2360.02 must be checked for cracks as follows:

- remove rear seat
- check the brackets for possible cracks, refer to illustration on page 2 (if necessary use mirror and flash light)

Caution: If cracks are determined, replace the brackets immediately IAW 1.8.2 !

1.8.2 Both forward C of G release hook attachment brackets must be replaced as follows:

- remove rear seat
- remove L/H and R/H instrument panel cover
- remove **front** attachment of the C of G hook (item 2, 3, 4), loosen rear attachment (item 12, 13, 14)
- remove attachment brackets (page 2, item 5 and 6)
- install new brackets P/N 103B-2360.01/2 and 103B-2360.02/2

Caution: On TWIN ASTIR and TWIN ASTIR TRAINER the additional plate P/N 103-2360.02 must be installed below the attachment brackets.
