## SERVICE BULLETIN NO. MSB 315-76/1 SERVICE BULLETIN NO. MSB 869-27/1

#### 1.4 Subject:

ATA-Code:                      27-60  
   Airbrake Control

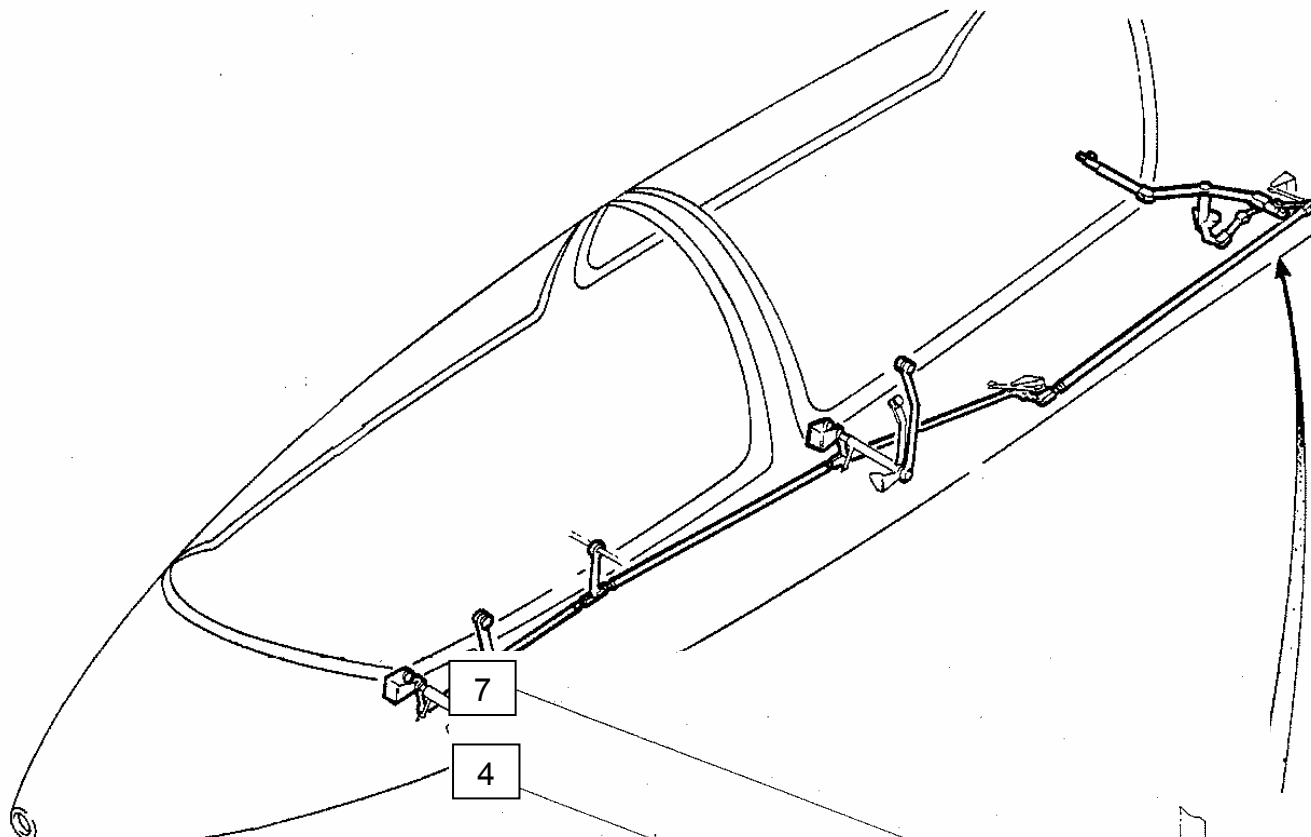
GROB received a report that a bolt in the airbrake control was found failed during a pre-flight inspection on a G 103C TWIN III ACRO.

During an extensive investigation (metallurgical investigation) a double sided fatigue crack was found as root cause. As the bolt is insignificantly stressed by cyclic bending the crack was probably caused by mean stress supported by a bolt torque exceeding the limit.

As a precautionary action the immediate exchange of the bolt and installation with the correct bolt torque is mandatory.

- 1.8.1 De-rig aircraft.
- 1.8.2 Remove rear seat.
- 1.8.3 Remove inner main wheel fairing.
- 1.8.4 Remove access cover behind the rear seat.
- 1.8.5 Remove bolt LN9037-M6x60 from the airbrake bell crank 103B-4437 and install new bolt. Use new locking nut LN9348-M6 (see figure on page 4). Bolt torque: 6.4 Nm (4.72lbs.ft)

Note: Alternatively bolt LN9037-M6x62 may be installed. Thereby use additional washer LN9037-6,4 under the bolt head.

- 1.8.6 Check visually all parts of the airbrake bell crank including the attachment parts for any damage (if required use magnifying glass 10x). Damaged parts must be replaced (see also table on page 4).
