Subject: Exchange of the spiral pin in the spindle drive

Concerned: G 103 C TWIN III SL, S/N's 35001 - 35050

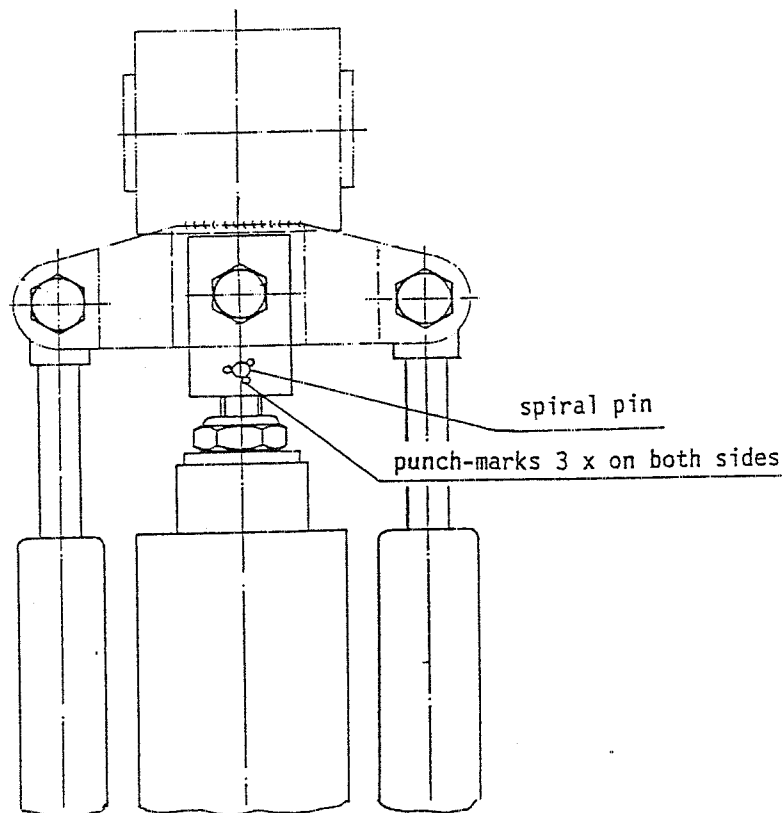
Reason: To prevent a loosening of the spiral pin in the spindle drive, the spiral pin must be exchanged and secured as a precautionary action.

- c. Drill up the hole to a dia. of 4 mm.
- d. Install the new spiral pin.
- e. Punch-mark the spiral pin three times on each side according to the sketch.
