Subject: Exchange of propeller switch 25 KB

Concerned: G 103 C TWIN III SL, all S/N's

Urgency: within the next 10 engine running hours,
but not later than 30 April 1993

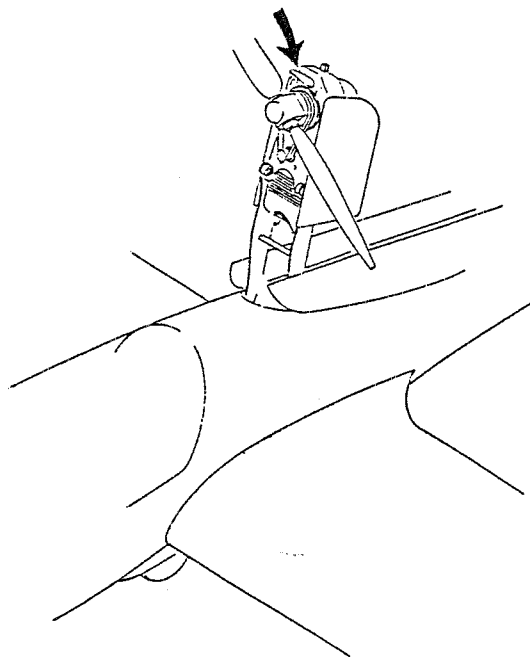
Vorgang: A propeller switch 25 KB, type BALLUFF, is mounted on the engine (see illustration below) which initiates retraction of the engine unit. After approx. 150 engine running hours, chafing through of the insulation of both cables inside this switch, caused by engine vibrations, has been detected. In this condition, the engine retracts immediately, if the ignition is switched to "OFF".

Note: The retraction can be prevented by one of the following procedures:

1. Switch on Ignition again: engine stops in the last position

2. Pull T-grip "Powerplant extension": engine extends fully, subsequently switch off "Engine Electrics".

In any case land, with the engine extended, as soon as possible, at the nearest airfield.
