SERVICE BULLETIN MSB 315-72 SERVICE BULLETIN MSB 869-23

1.4 Subject:

ATA-Code:	55-00	Stabilizer
	55-40	Rudder

TWIN II; TWIN II ACRO; TWIN III; TWIN III ACRO; TWIN III SL

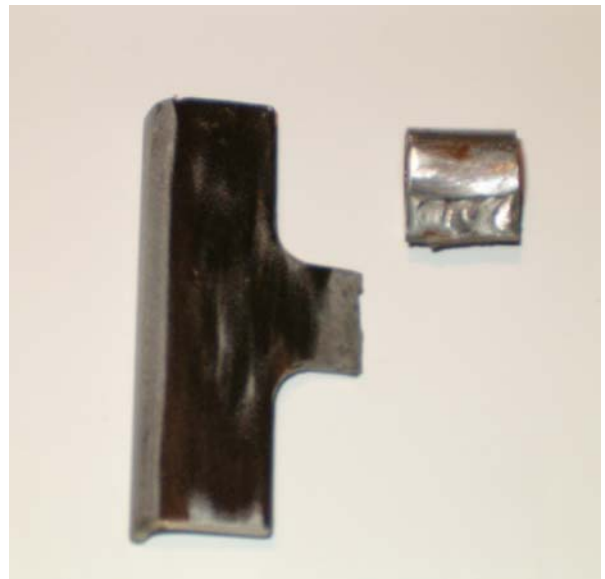
Abb. 2

Note: Capillary fissures may be observed between rudder hinge and surrounding GRP, this is entirely normal, since metal and GRP do not form a homogeneous structure.
