SERVICE BULLETIN NO. MSB306-37/2 MSB320-08/2

Modification of the Canopy Jettison System

Standard Astir II
Club Astir II
SPEED ASTIR II
SPEED ASTIR IIb

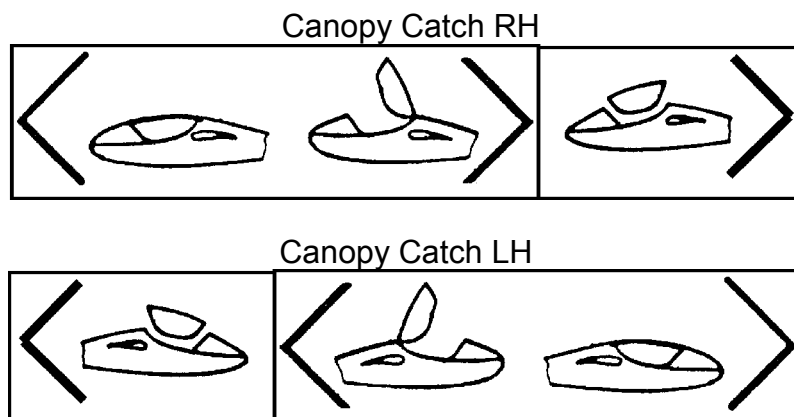
B. At the LH and RH canopy both placards “Canopy Catch” must be replaced by the new placards (“Canopy Catch + Emergency Jettison”):
