SERVICE BULLETIN MSB 306-35

ATA - Code: 27-00 Flight Controls

G 102

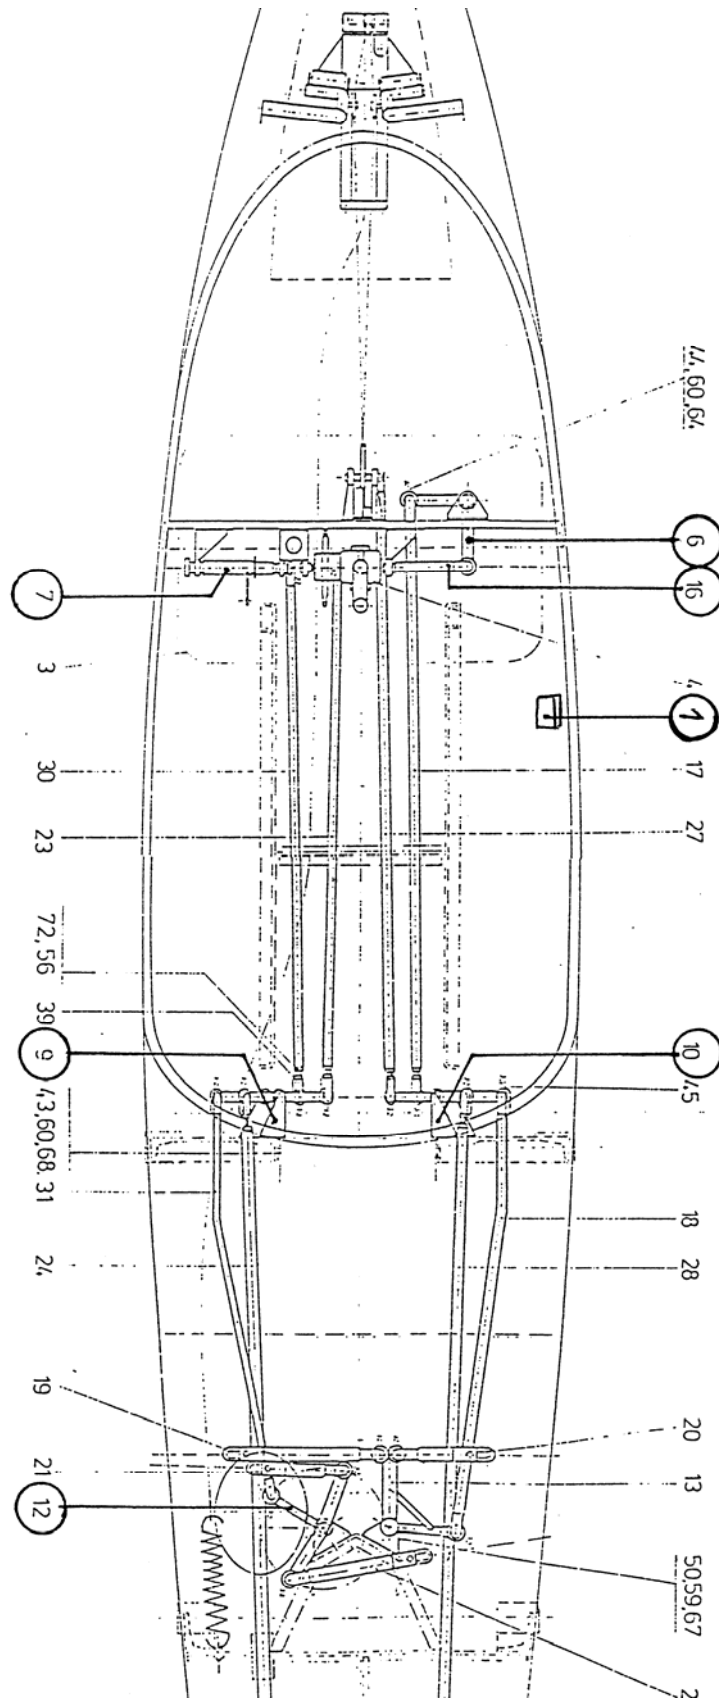
GROB received isolated discrepancy reports regarding cracks on welded parts of the flight control system of the type G102, model CLUB ASTIR III & IIIb, and STANDARD ASTIR III. The cracks progress slowly from the welding seams periphery, and may eventually result in rupture at a matured stage. No abrupt or immediate failures of complete components were observed. As a precautionary measure, all welded parts shall be inspected, and exchanged if necessary.

1.8.1 a) Welded parts of the flight control system (as listed below) shall be inspected for development of cracks or permanent distortion. (# numbers, refer to drawing page 5):

- | | | |

| - Aileron lever I | 102C3-4225 | (# 6) |
| - Aileron rod I | 102C3-4351 | (# 16) |
| - Air brake-trim-unit | 102C3-4230 | (# 7) |
| - Bell crank | 102C3-4261/ 4262 | (# 9, 10) |
| - Air brake lever III | 102C3-4266 | (# 12) |
| - Undercarriage lever | 102S3-5214 | (only G 102 STANDARD III) (# 1) |

b) The visual inspection may be executed with a magnifying glass (min. 1:10), whilst parts are installed. In any case of doubt, the affected parts shall be removed for inspection.

d) In case cracks or permanent deformations are observed during inspection, the affected welded part shall be replaced with a new part before the next flight.

Caution: Repair of cracked or deformed flight control elements is not approved.

- 1.8.3 Welded flight control elements (as per listing step 1.8.1 a) shall be replaced with new parts as required.
