## SERVICE BULLETIN NO. MSB306-38

**TCDS-No. 306 (FAA TC No. G33EU):**  
ASTIR CS                      S/N 1001 - 1536

**Inspection of the vertical stabilizer attachment**

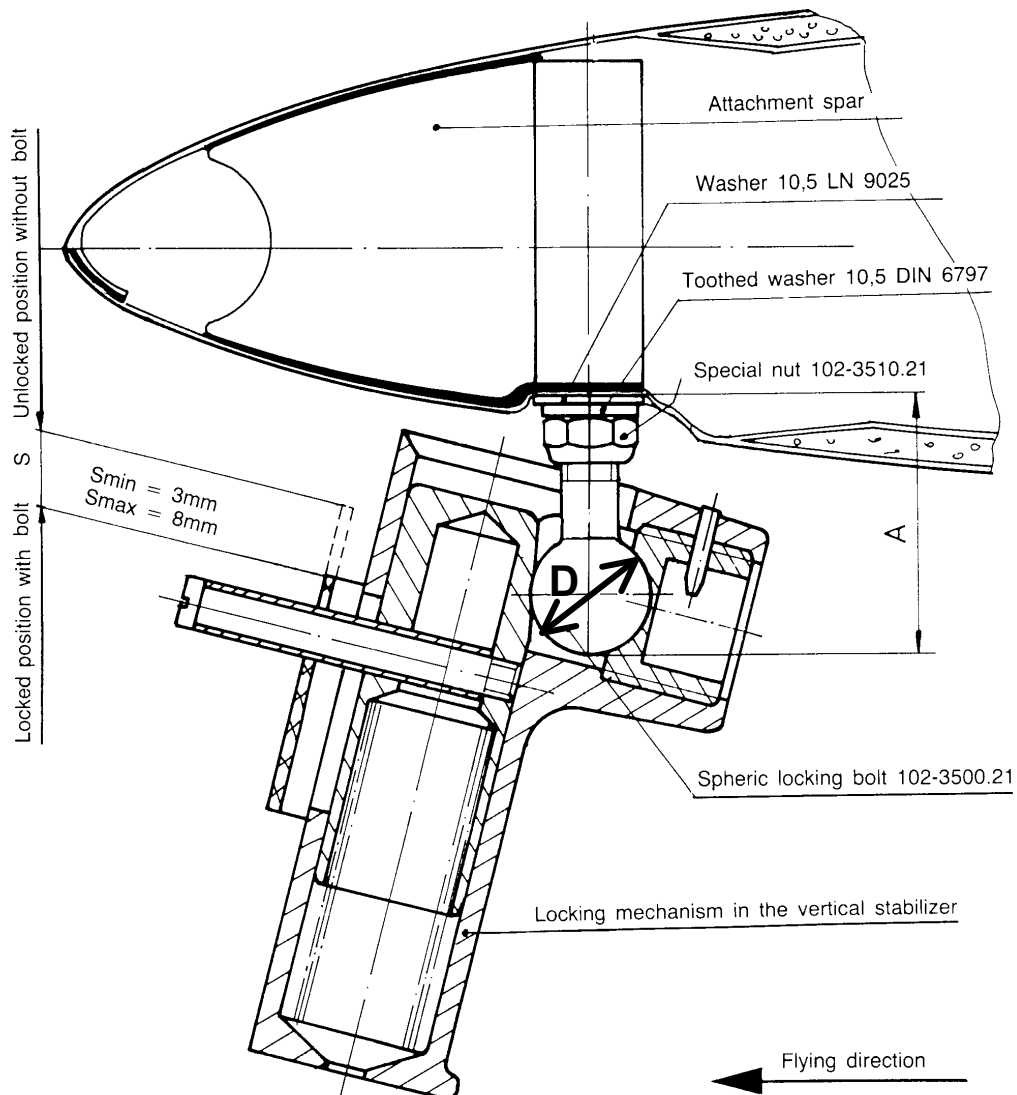
An incident was reported, where the spherical locking bolt of the horizontal stabilizer attachment was broken after landing. The investigation has proved a fatigue crack caused by alternating stress on to the stabilizer with unsymmetrical loads. This fatigue failure could have been caused by various external influences. To prevent further incidents the inspection of the front and rear vertical stabilizer attachment and especially an inspection of the spherical bolt P/N 102-3500.21 is mandatory.

1.8.2 Inspect and replace the spherical locking bolt as follows:

- remove horizontal stabilizer according to the Flight Manual and lay down in a proper device
- determine and note the exact installation depth "A"

- loosen the hexagon nut P/N 102-3510.21 (14 mm wrench) and remove spherical bolt using a screw driver
- inspect the thread of the bolt (especially in the area nut/ socket) for cracks or damage (using magnifying glass x20 or dye penetrant testing)
- if a crack or any indication for crack starting is found, the bolt must be replaced immediately

- install the inspected or new spherical bolt, thereby pay attention for the correct installation depth
- tighten hexagon nut P/N 102-3510.21 with torque 20 Nm (tolerance +4, -2) holding the bolt using a screw driver
- install horizontal stabilizer
- check and adjust if necessary the stabilizer angle of incident according to the Flight Manual
