Technical Information  
TM 315-12

TWIN ASTIR  
TWIN ASTIR  
TRAINER

**Subject:** Replacements of Hotellier Quick-links of the control system.

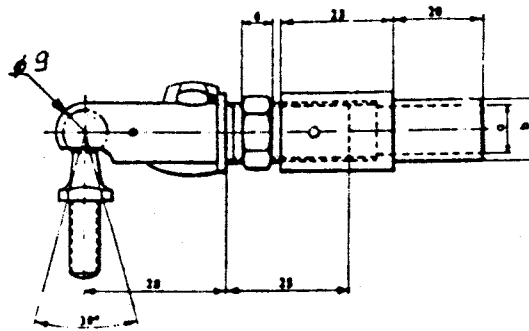
Detail N°. 1

**Correct**  
joint with normal  
swivel-housing  
R 9.41  
for elevator

At the elevator ass'y, if not yet installed, the open-housing-type joint R Z 9.41. (detail N<sup>o</sup>. 3) will be replaced by a joint R 9.41. (detail N<sup>o</sup>. 1) with normal housing. Swivelsize of 9 mm remains unchanged.

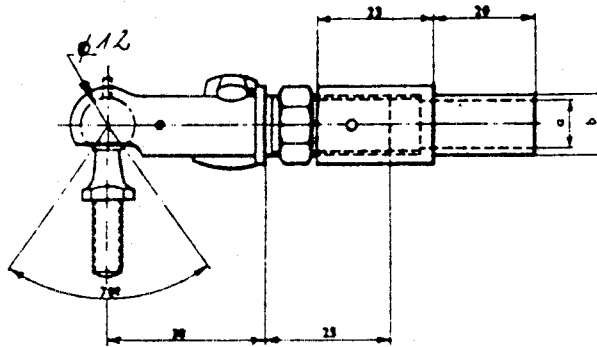
Detail N°. 2

**Correct**  
joint with normal  
swivel-housing  
R 12.41  
for aileron

Installed joints R Z 9.41. (open housing) with 9 mm swivel diameter (detail N° 3) of the aileron control ass'y must be replaced by joints R 12.41 (detail N° 2) (normal housing) with 12 mm swivel diameter and installed swivels N° 961 M (detail N° 4) by swivels N° 262 M (detail N° 5).

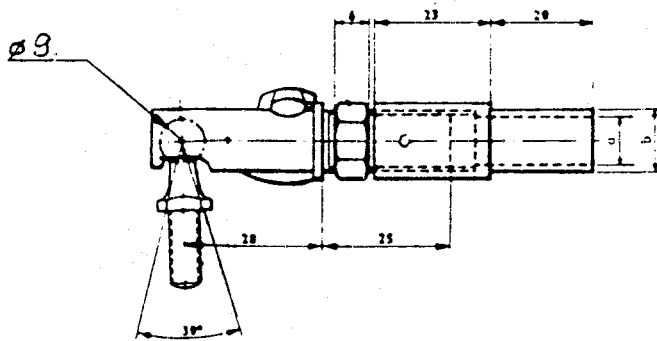
Detail N°. 3

**Reason:** After a high total aircraft time several fractures of 90° quick-connections with open housing (Z-type) due to strong wear and tear were observed at the swivels of the aileron control system which requires the general exchange of the above mentioned joints against those with closed housing and new swivels.

**not permitted**  
joint with open  
swivel-housing  
(Z-housing)  
RZ 9.41.

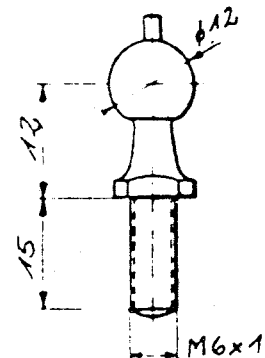
Detail N°. 5

Swivel  
N°. 262 M  
for aileron
