Subject: Inspection and, if necessary, exchange of the elevator push-rod III (103A-4244) or the elevator push-rod IV (103A-4694) respectively.

Effectivity: Gliders GROB G 103 A TWIN II ACRO s/n 3544 - 3878 (inclusive) (only with supplement "K").

Service Bulletin
TM 315-34

GROB G 103 A
TWIN II ACRO

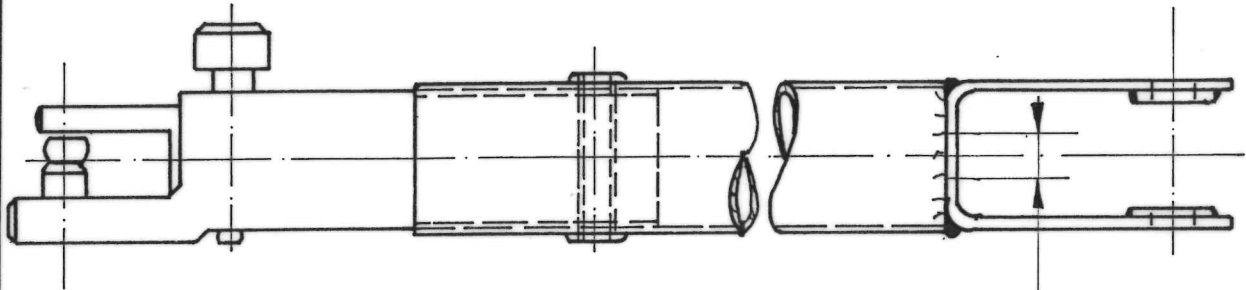
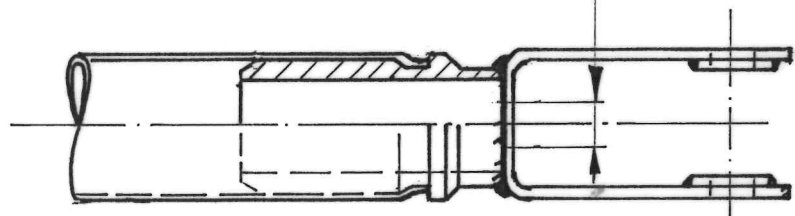
Reason: Corrosion may occur in the lower mounting area of the described elevator push-rod through water of condensation. As a precaution, the elevator push-rod is inspected and, if necessary, exchanged.

1. Remove rudder
2. Remove elevator push-rod (elevator push-rod III 103A-4244 or elevator push-rod IV 103A-4694 respectively)
3. Inspect the elevator push-rod for water of condensation and corrosion as follows:
 - a) The elevator push-rod must be drilled on the lower fork head end according to the drawing (hole dia. 6 mm)
 - b) Check whether water of condensation comes out. In the affirmative, the elevator push-rod must be replaced by a new one.
 - c) In the negative, the tube must be knocked up to 100 mm after the lower fork head end (e.g. with the wooden handle of a screw driver). If by doing so, rust is falling out of the hole, the elevator push-rod must be replaced by a new one.
4. In case a new elevator push-rod is needed, the old one must be returned to the manufacturer.

HOLE DIA. 6mm

5. In case the existing elevator push-rod can be used, it must be treated inside with the above mentioned corrosion preventative before installation. The hole remains open.
