Service Bulletin  
TM 315-37

GROB  
G 103 TWIN II  
G 103 A TWIN  
II ACRO

Subject: Inspection and reinforcement of welded parts in the flight control system of the gliders GROB G 103 TWIN II and G 103 A TWIN II ACRO. The following welded parts will be reinforced:

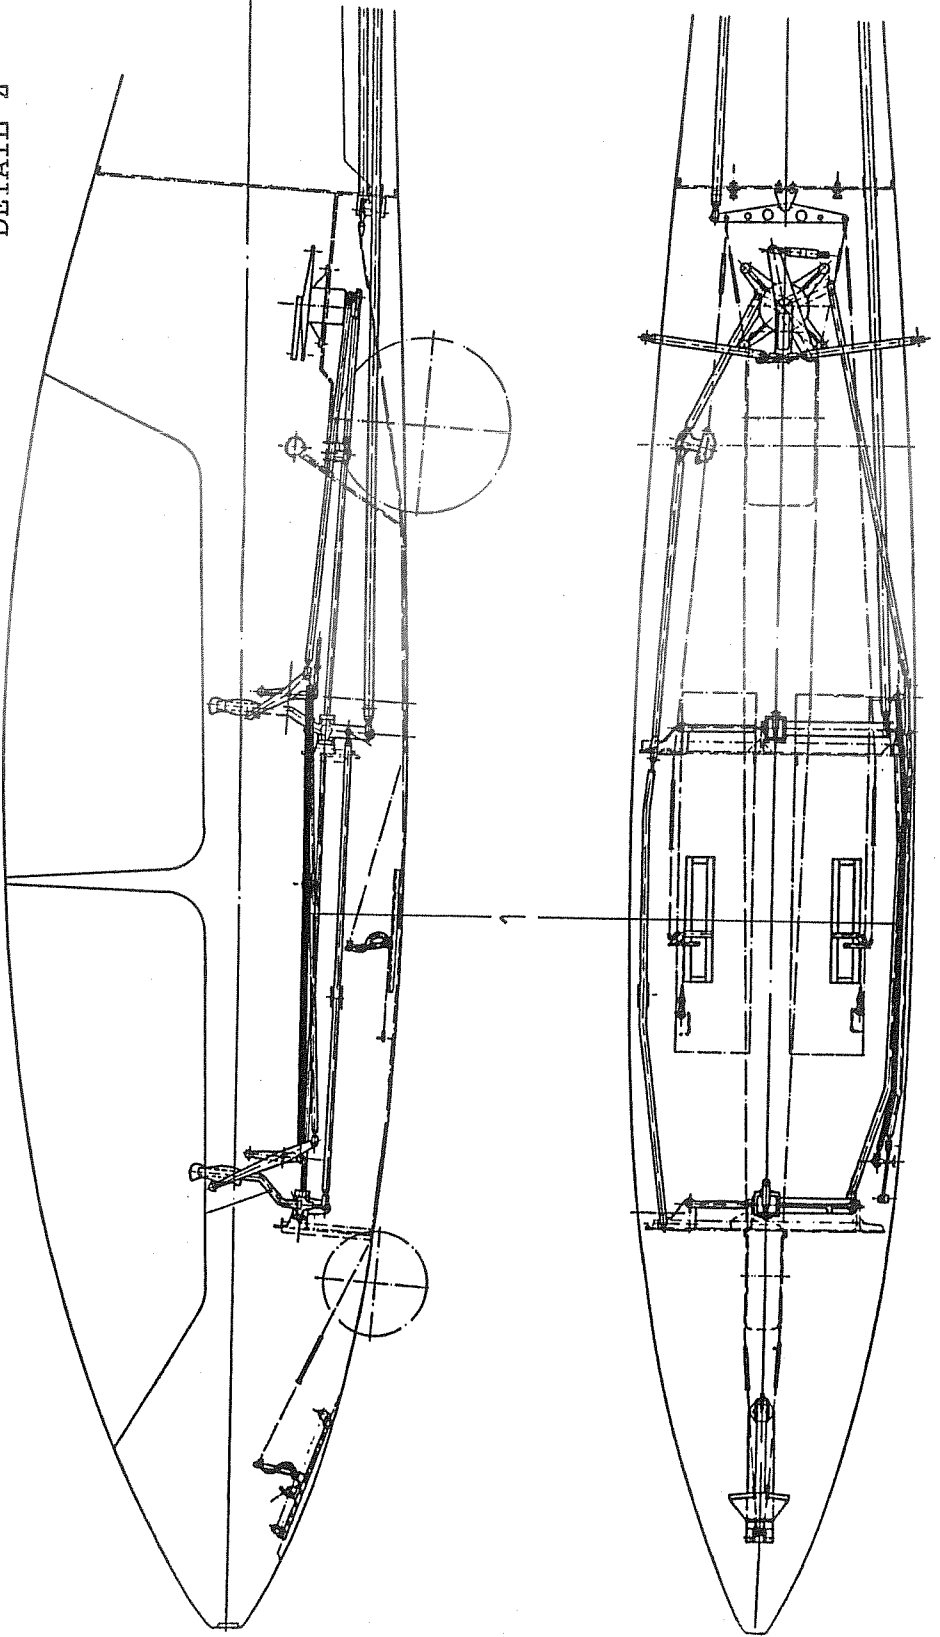
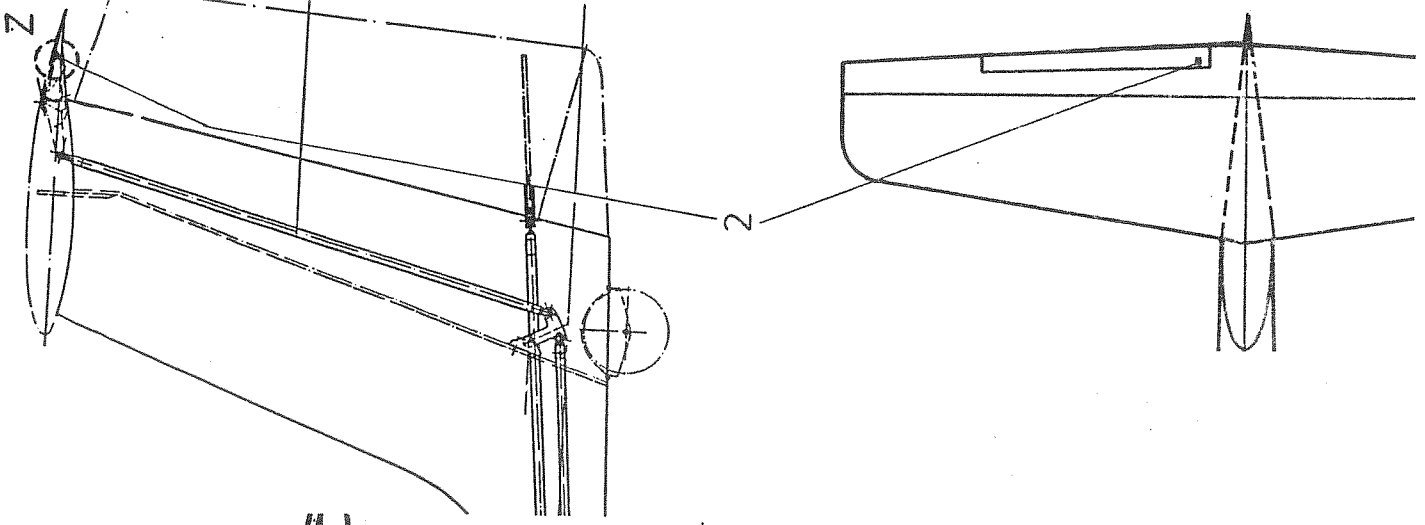
DETAIL Z

Explanatory Sheet for the Execution of Instruction 1 of TM 315-37  
for s/n 3501 - 3729

The control system parts shown below have to be inspected for cracks and deformations.

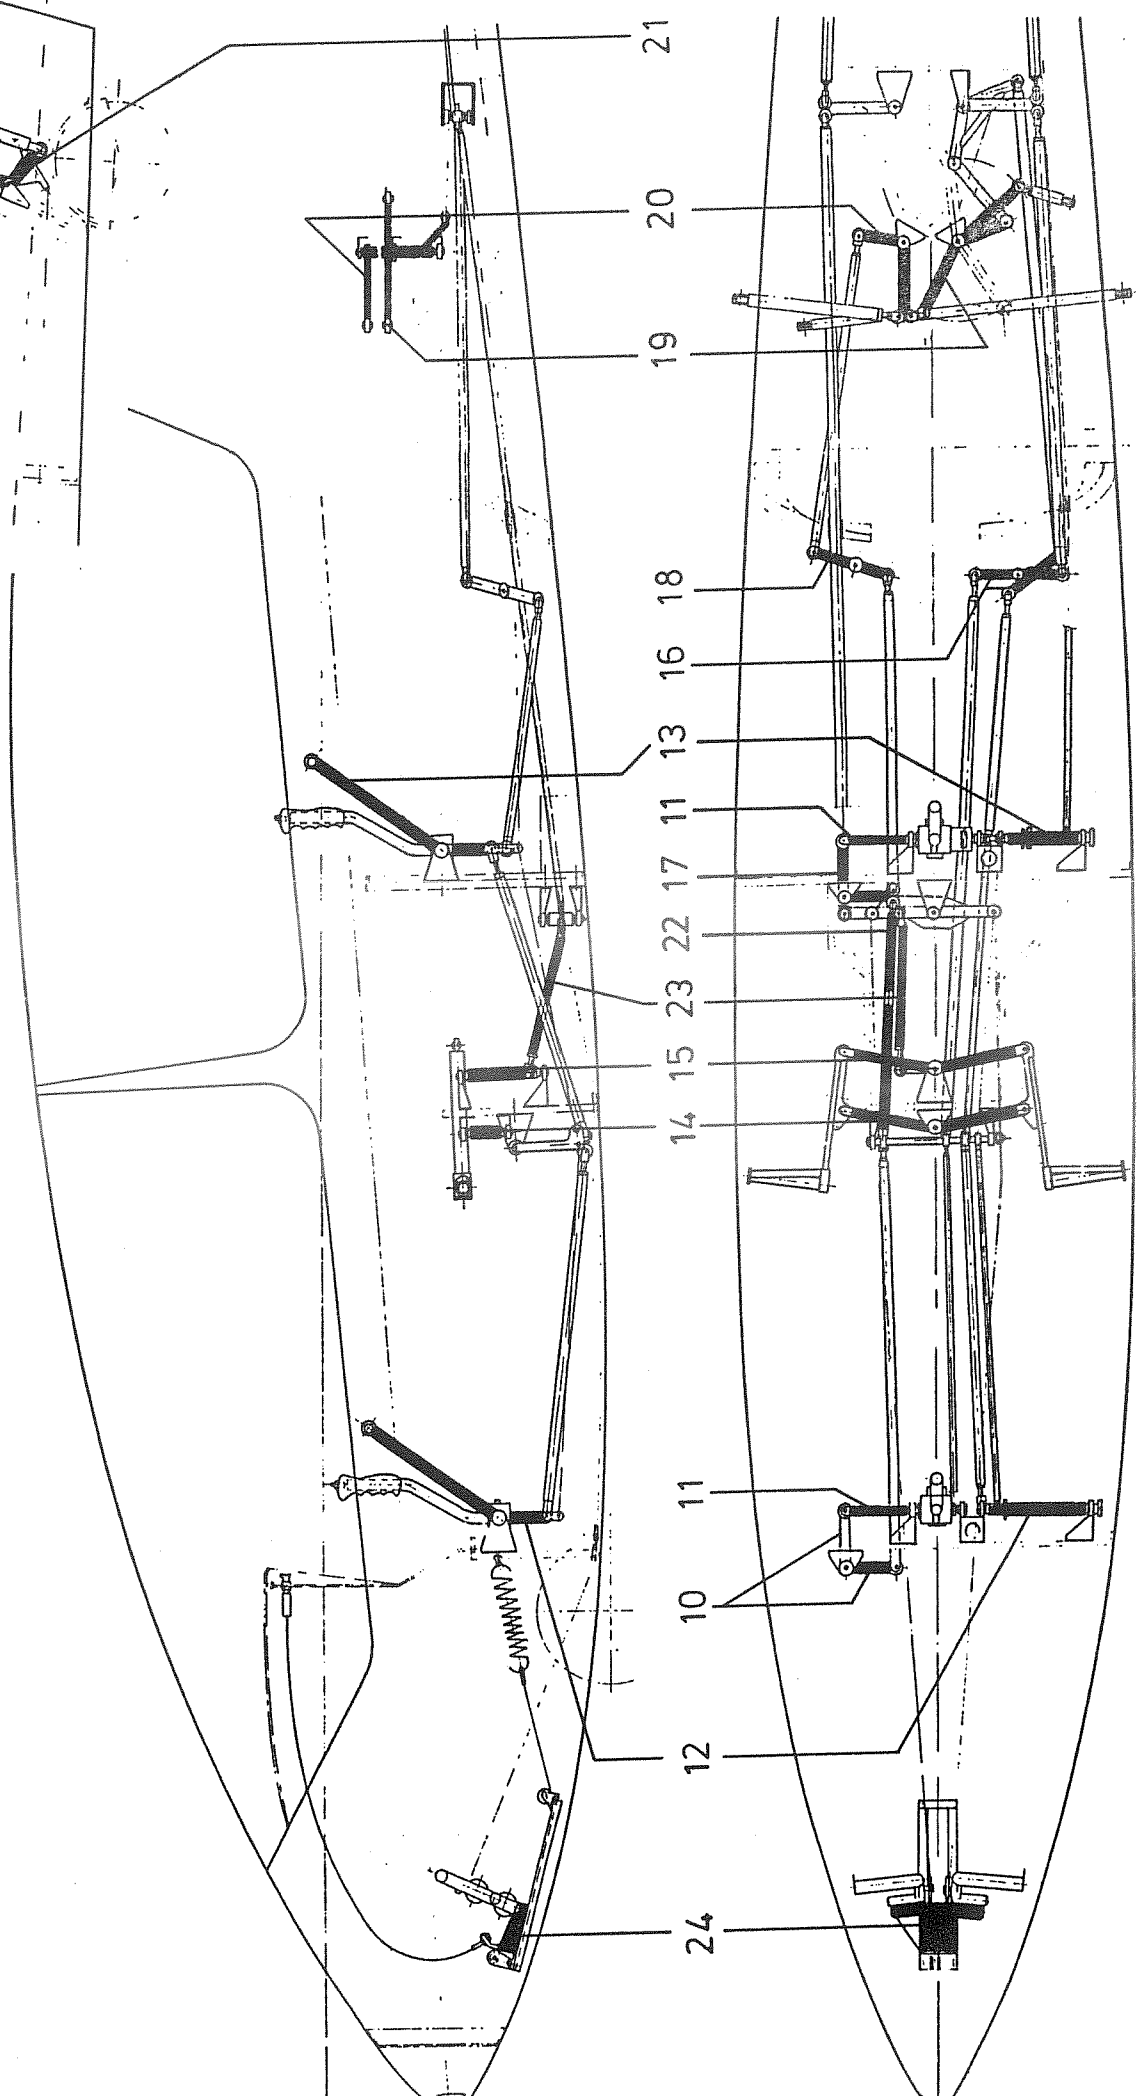
Explanatory Sheet for the Execution of Instruction 1 of TM 315-37

The control system parts shown below have to be inspected for cracks and deformations in the area of the welds.
