Subject: Modification of the wing-fuselage connecting rods

Concerned: Sailplane Model: TCDS No. 315
 TWIN ASTIR S/N 3000 - 3291
 TWIN ASTIR TRAINER S/N 3000 - 3291 (with suffix "T")
 G 103 TWIN II S/N 3501 - 3729

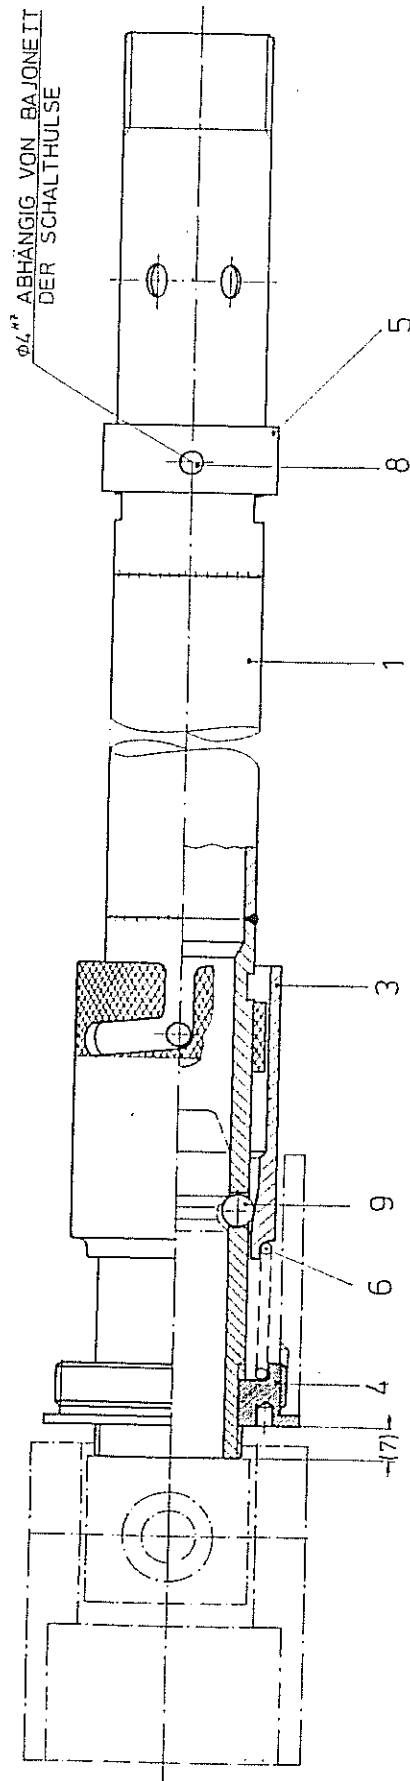
Connector 103-2201/ 2202

Procedure: Some parts of the wing-fuselage connecting rods P/N 103-2201/ 2202 are not manufactured any longer and so this parts can't be delivered as spares. Due to this fact the wing-fuselage connecting rods may be modified optionally during spares delivery or repair. This modification corresponds to the standard of the wing- fuselage connecting rods installed in the later glider models.

1. The modifications to the wing-fuselage connectors will be performed in accordance to the following drawings:

Drawing No.	Issue	Name
103-2201.03	05.09.1977	Socket
103-2201.06	05.09.1977	Ring
