This Service Bulletin substitutes the Service Bulletin 315-61, dated 06 May 1999.

Subject: Inspection/ Replacement of the knurled nut at the rear control stick

Sailplane Model:	TCDS No. 315
G 103 TWIN II	S/N 3501, - 3729
G 103A TWIN II ACRO	S/N 3501 - 3729 (with suffix "K")

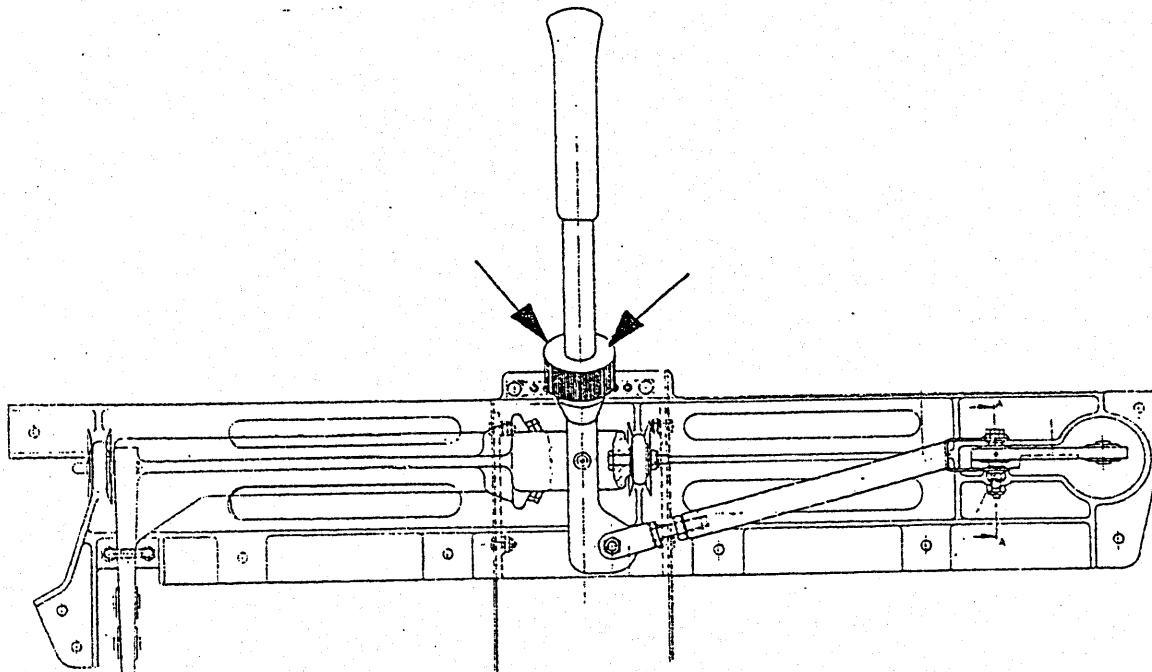
Background Information: Single cases had been reported to GROB, where the fastening nut (knurled nut) was cracked. Previous investigations showed, that these damages may be caused by improper handling i.e. fastening the nut too tight. As a precautionary action an inspection or replacement of the knurled nut is mandatory.

1. The knurled nut must be checked for damage, especially for cracks on the upper side of the nut. **If the nut is found damaged or cracked, the nut must be replaced immediately.**

2. The inspection must be repeated before the first flight of a day, until the knurled nut is replaced.
3. The knurled nut at the rear control stick must be replaced for a new knurled nut made from stainless steel.
