Subject: Inspection/ Replacement of the knurled nut at the rear control stick

Concerned: Sailplane Model: TCDS No. 315
G 103 TWIN II S/N 3501 - 3729
G 103 TWIN II ACRO S/N 3501 - 3729 (with suffix "K")

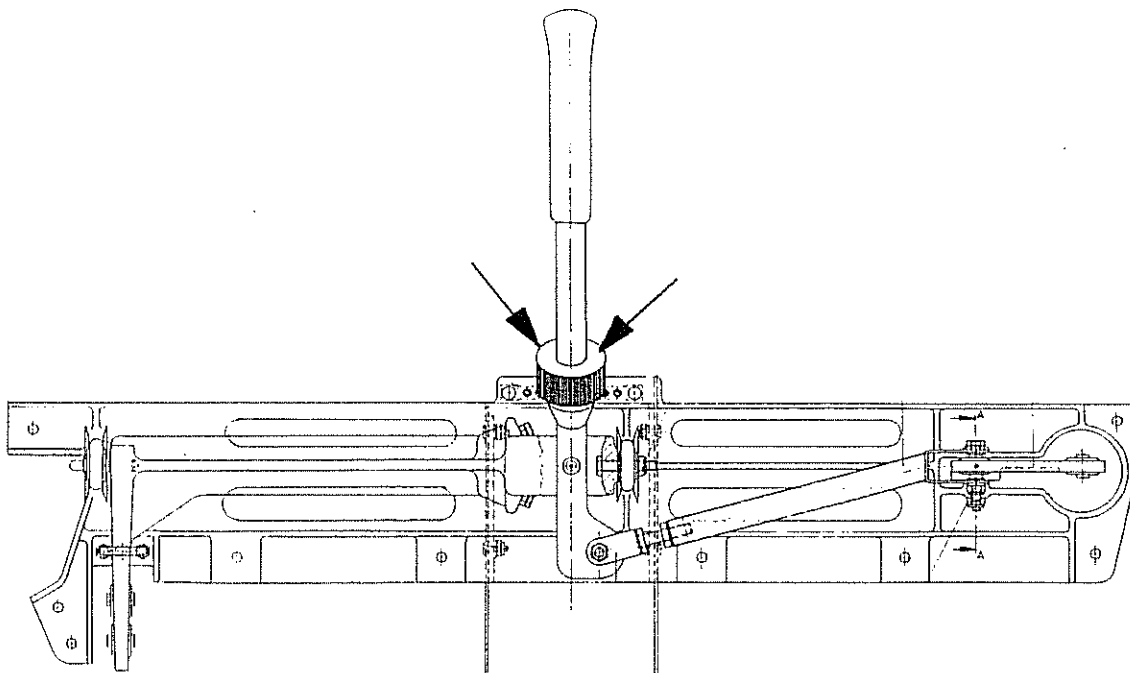
Background information: Single cases had been reported to GROB, where the fastening nut (knurled nut) was cracked. Previous investigations showed, that these damages may be caused by improper handling i.e. fastening the nut too tight. As a precautionary action an inspection or replacement of the knurled nut is mandatory.

1. The knurled nut must be checked for damage, especially for cracks on the upper side of the nut. **If the nut is found damaged or cracked, the nut must be replaced immediately.**

2. The inspection must be repeated before the first flight of a day, until the knurled nut is replaced.
3. The knurled nut at the rear control stick must be replaced for a new knurled nut made from stainless steel.

Material: The new knurled P/N 103-4205.03/2 is attached to the Service Bulletin.
