**Subject:** Inspection and replacement of spar spigot assemblies

**Concerning:** Model: ASTIR CS TCDS No.: 306  
- Series: - S/N:  
ASTIR CS 1001-1536  
ASTIR CS 77 1601-1844  
ASTIR CS Jeans 2001-2248  
CLUB ASTIR II 5001-5061 (Suffix "C")  
STANDARD ASTIR II 5001-5061 (Suffix "S")  
G 102 CLUB ASTIR III 5501 & up (Suffix "C")  
G 102 CLUB ASTIR IIIb 5501 & up (Suffix "Cb")  
G 102 STANDARD ASTIR III 5502 & up (Suffix "S")

Model: SPEED ASTIR II TCDS No.: 320  
- Series: - S/N:  
SPEED ASTIR II 4001-4027  
SPEED ASTIR IIB 4028-4107

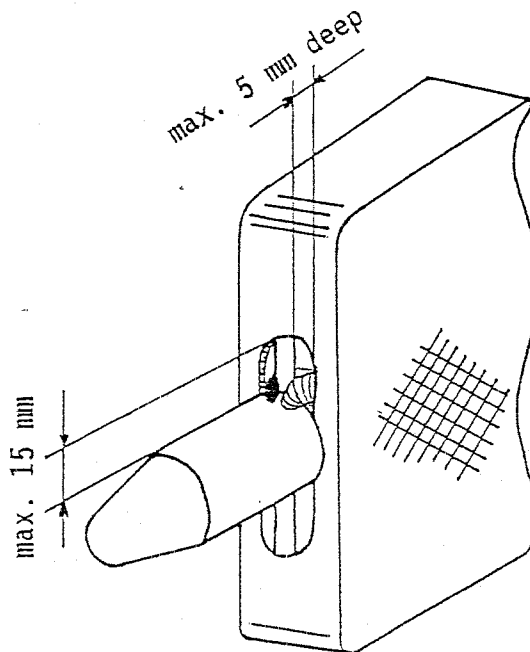
To perform the crack inspection the section of the wrapping around the main spigot has to be removed (max. 15 mm) and the adhesive material removed to expose the welding seam (max. 5 mm deep, see figure). Be very careful not to scratch or otherwise damage the spigot or plate.

If the weld seam is continuous around the plate, the complete toe of the welding seam has to be inspected. Grooves or nicks in the surface of the welding seam which are not part of a crack must be polished out and the crack inspection performed again.

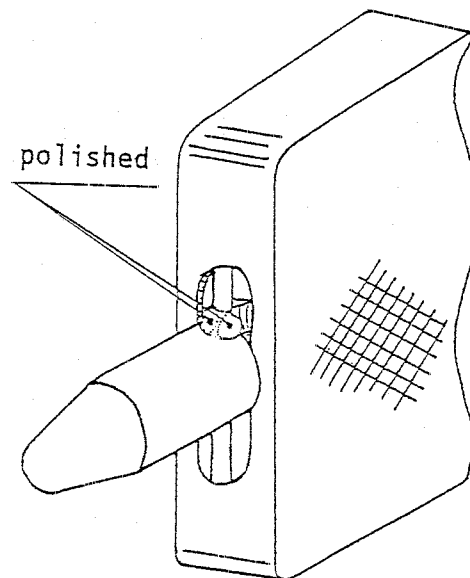
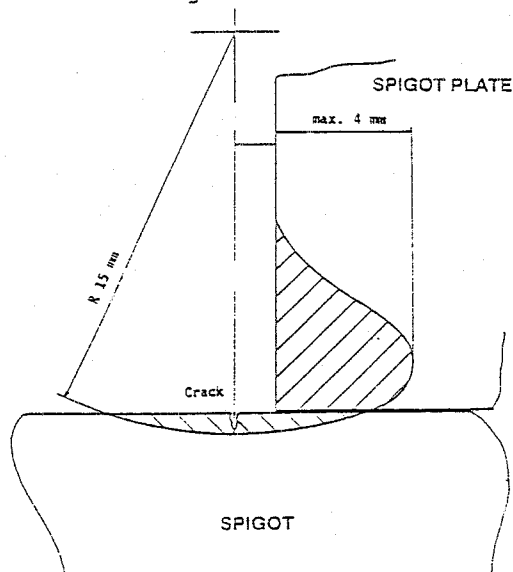
A crack may be blended out if the following conditions are fulfilled:

- \* crack on one side not deeper than 0.75 mm
- \* cracks on both sides not deeper than 0.5 mm each

Blending out should be done with grinding caps or equivalent. The grinded surface has to be polished.

Finally apply a coating of resin to the exposed area (wood and metal).
