**Subject:** Inspection and, if necessary, modification of the auxiliary battery frame

**Concerned:** G 103 C TWIN III SL, S/N 35001 to 35033 (as of S/N 35034 standard)

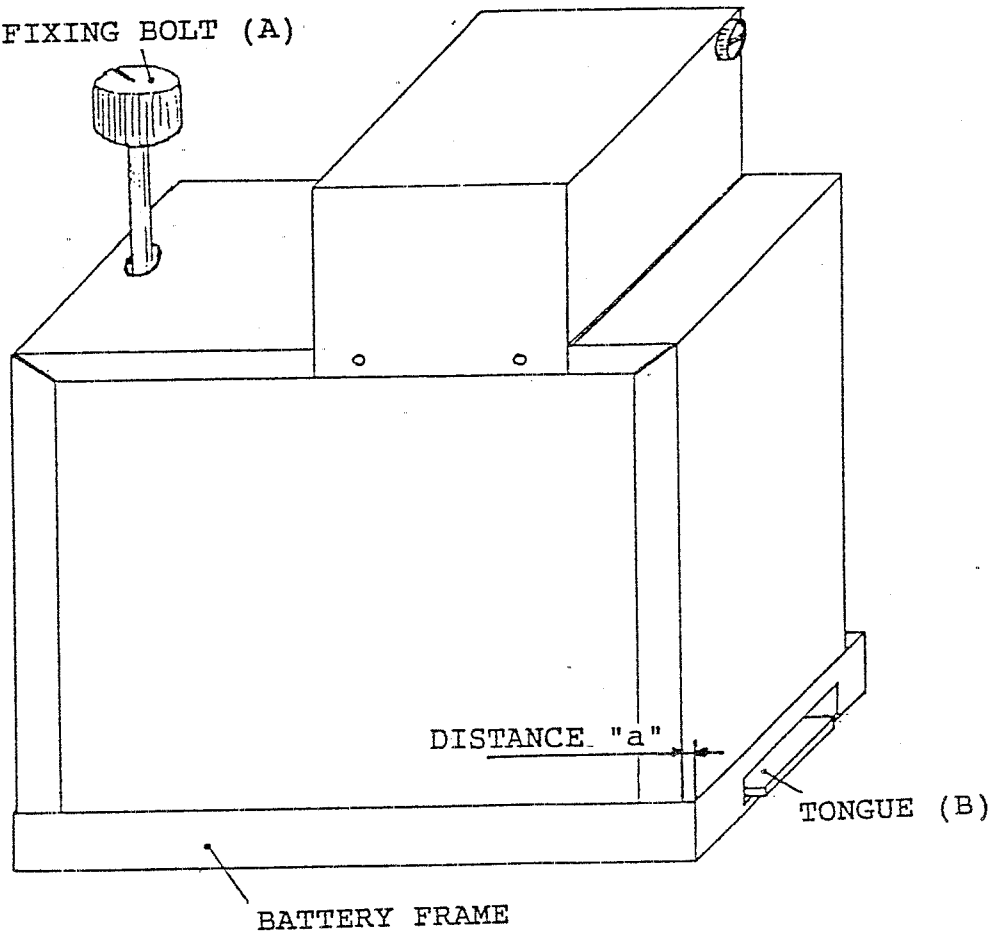
BATTERY FIXING BOLT (A)

**Procedure:** Depending on manufacturing tolerances by the supplier, it is possible that the auxiliary battery may come out of its frame. In adverse circumstances jamming of the controls may occur.

1. Check the distance "a" (refer to drawing on page 2) when the battery fixing bolt (A) is loosened  
If the distance "a" is:  
< 2 mm : no further action is required  
> 2 mm : perform action 2
2. Modification of the auxiliary battery frame according to Installation Instruction No. 869-2
