Subject: Inspection of the upper pulley wheel

Concerned: G 103 C TWIN III SL, S/N's 35001 - 35048

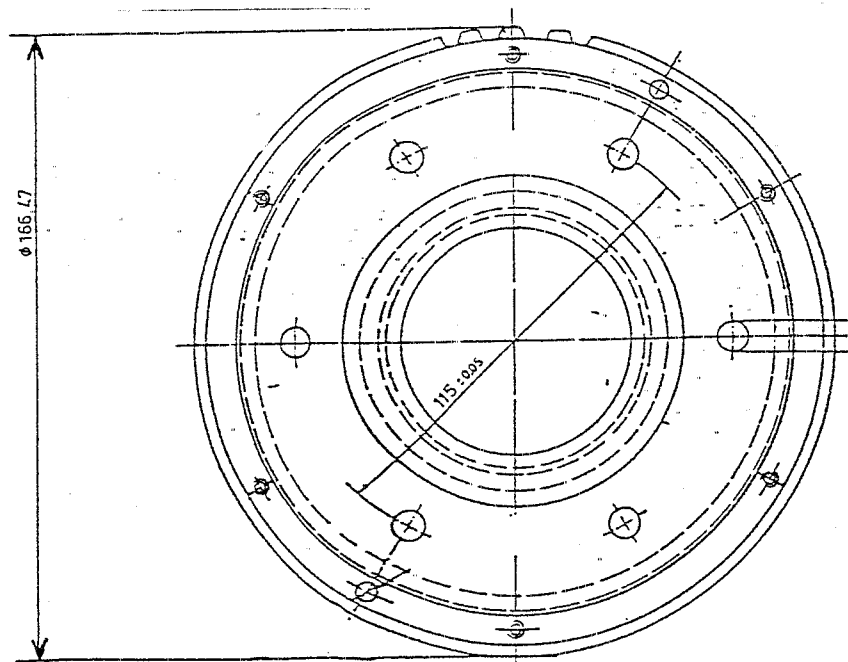
Reason: During starting operation both propeller drive belts of a TWIN III SL failed. Although it was an individual case, an inspection for true measurement of the upper pulley wheel (diameter of the pulley wheel) is ordered as a security measure.

1. The diameter of the upper pulley wheel should be measured as follows:
 - a. Remove the R/H and L/H engine fairing.
 - b. Using a sliding caliper (minimum arm length 100 mm) measure the outer diameter of the pulley wheel between the drive belts. It may be beneficial to add round stock i.e. welding wire (approximately ϕ 3 mm) to the arms of the sliding caliper, to aid in making the diameter measurement easier.

2. If the diameter of the pulley wheel is $166,47 + 0,1$ mm, no further actions are required.
3. If the diameter of the pulley wheel is greater than 166,6 mm, the pulley wheel must be exchanged according to the Maintenance Manual page 6.11.
