SERVICE BULLETIN NO. MSB 315-75 SERVICE BULLETIN NO. MSB 817-53 SERVICE BULLETIN NO. MSB 869-26

1.4 Subject:

Aileron Control, Elevator Control

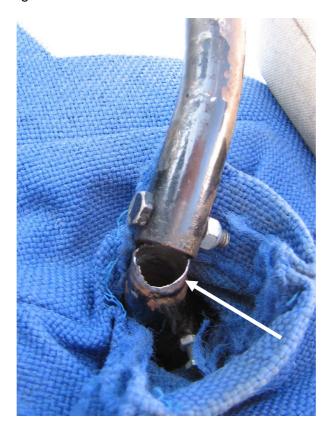
GROB received a report that a rear control stick (welded design) failed on a G 103 TWIN II after about 2600 flight hours.

Although no extensive investigation (metallurgical investigation) could not be performed up to now, a one-time inspection of the rear control stick respectively the RH stick on G 109/ G 109B (same design standard than on the concerned type) is mandatory as a precautionary action to find possible, unnoticed damages and/ or corrosion.

- 1.8.1 Remove control stick cover and release attachment bolt and remove upper control stick.
- 1.8.2 Inspect upper and lower part of the control stick for damage and corrosion.

- 1.8.3 De-rig aircraft and remove control stick unit as far as required.
- 1.8.4 Determined damages or corrosion must be removed in the approved range I.A.W. "Aircraft Inspection and Repair FAA AC 43.I3-IA" or new parts must be installed.

- 1.8.5 Re-install control stick unit. If necessary use new attachment parts.
- 1.8.6 Install control stick. Apply and tighten attachment bolt. The standard torque is to be used.
- 1.8.7 Check controls for free and easy movement for correct sense of deflection.

The inspection must be repeated during each annual inspection/ 100 hours inspection.
