## SERVICE BULLETIN NO. MSB 315-76/1 SERVICE BULLETIN NO. MSB 869-27/1

#### 1.4 Subject:

ATA-Code:                      27-60  
   Airbrake Control

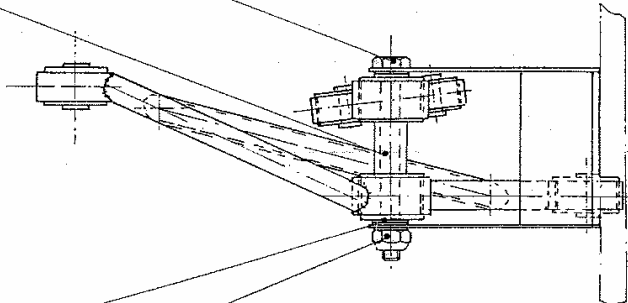
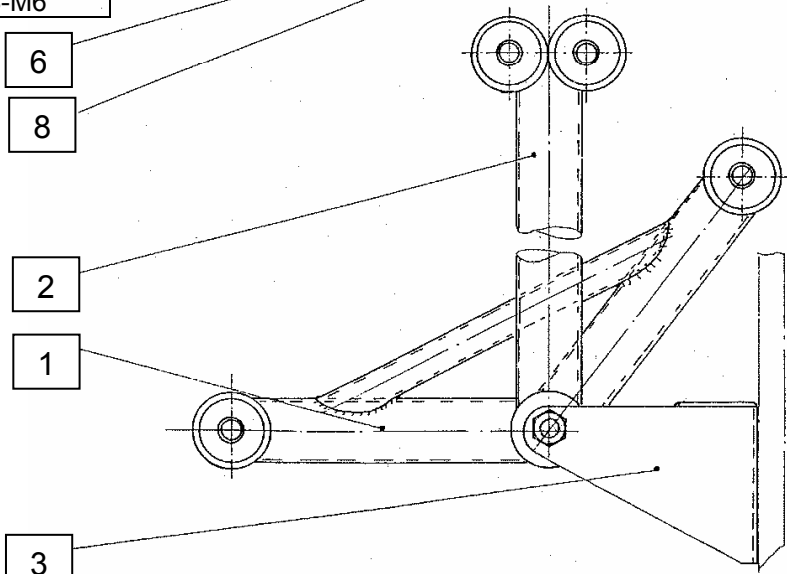
GROB received a report that a bolt in the airbrake control was found failed during a pre-flight inspection on a G 103C TWIN III ACRO.

During an extensive investigation (metallurgical investigation) a double sided fatigue crack was found as root cause. As the bolt is insignificantly stressed by cyclic bending the crack was probably caused by mean stress supported by a bolt torque exceeding the limit.

As a precautionary action the immediate exchange of the bolt and installation with the correct bolt torque is mandatory.

- 1.8.6 Check visually all parts of the airbrake bell crank including the attachment parts for any damage (if required use magnifying glass 10x). Damaged parts must be replaced (see also table on page 4).
