Subject: Modification of the wing-fuselage connecting rods

Concerned: Sailplane Model: TCDS No. 315
 TWIN ASTIR S/N 3000 - 3291
 TWIN ASTIR TRAINER S/N 3000 - 3291 (with suffix "T")
 G 103 TWIN II S/N 3501 - 3729

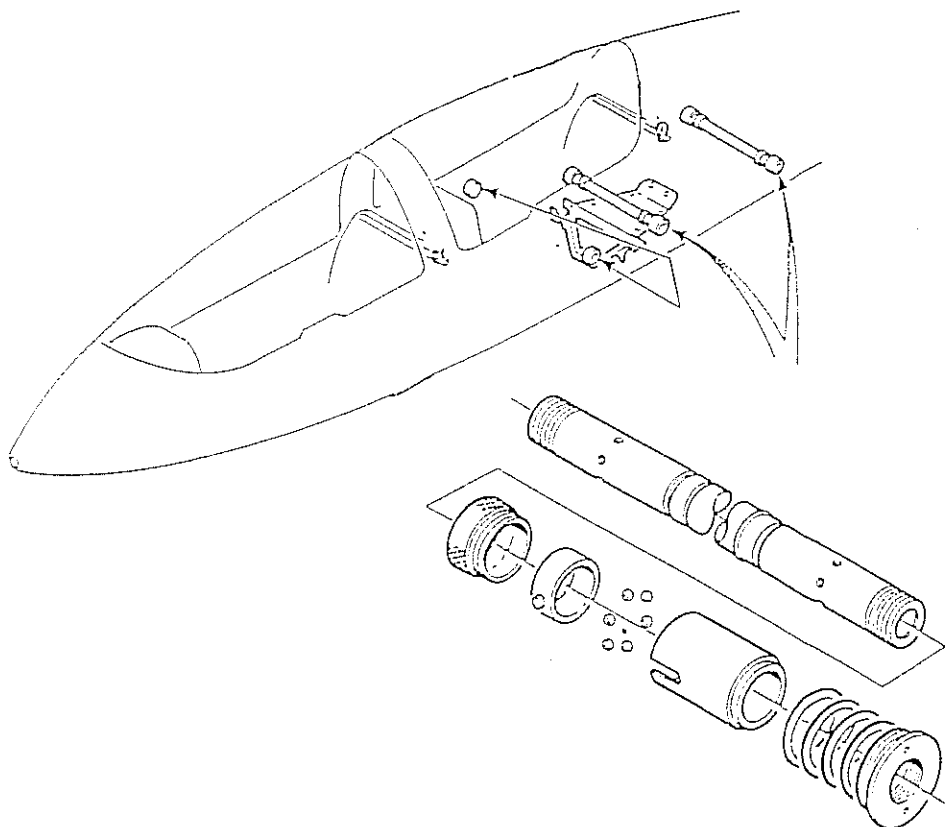
Procedure: Some parts of the wing-fuselage connecting rods P/N 103-2201/ 2202 are not manufactured any longer and so this parts can't be delivered as spares. Due to this fact the wing-fuselage connecting rods may be modified optionally during spares delivery or repair. This modification corresponds to the standard of the wing- fuselage connecting rods installed in the later glider models.

1. The modifications to the wing-fuselage connectors will be performed in accordance to the following drawings:
